Inspection Report

Property Address:
31468 King Valley West
Conifer CO 80433

Liberty Home Inspections, LLC

Date: 11/18/2019	Time: 09:00 AM	Report ID: 20191118-31468-King-Valley-West
Property: 31468 King Valley West Conifer CO 80433	Customer: Daniel Holton	Real Estate Professional: Lynn Westfall

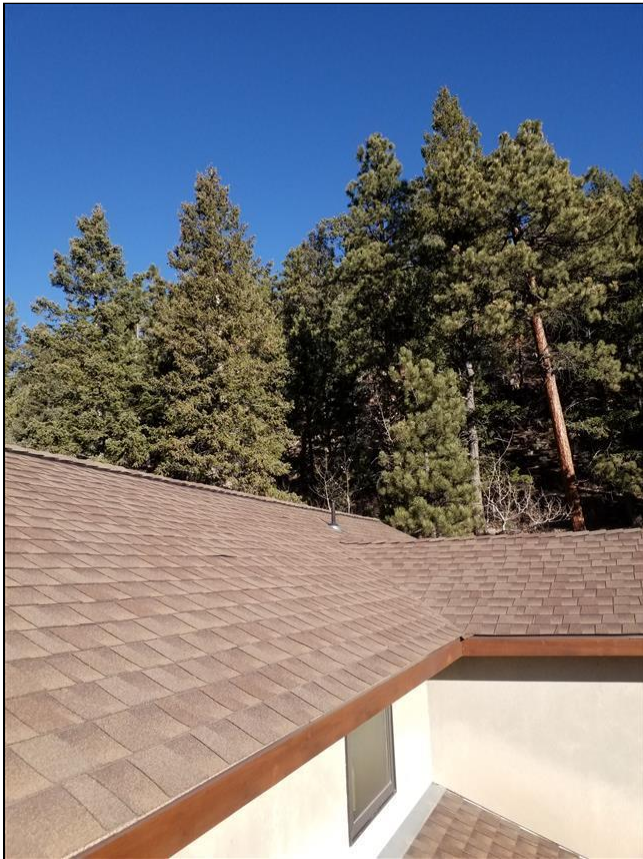
1.0 Item 1(Picture)

1.0 The roofing material is in good condition with no obvious signs of deterioration or defects.

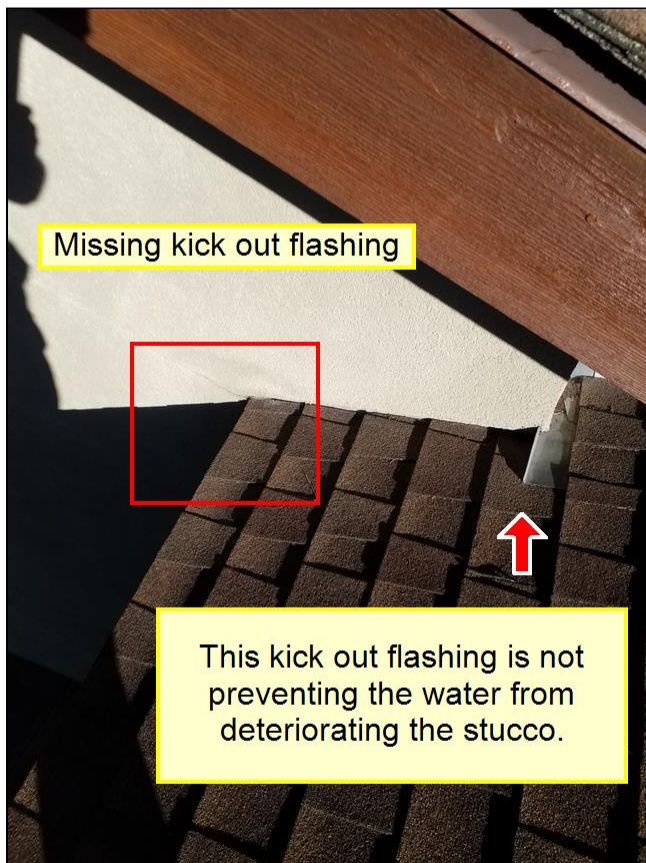
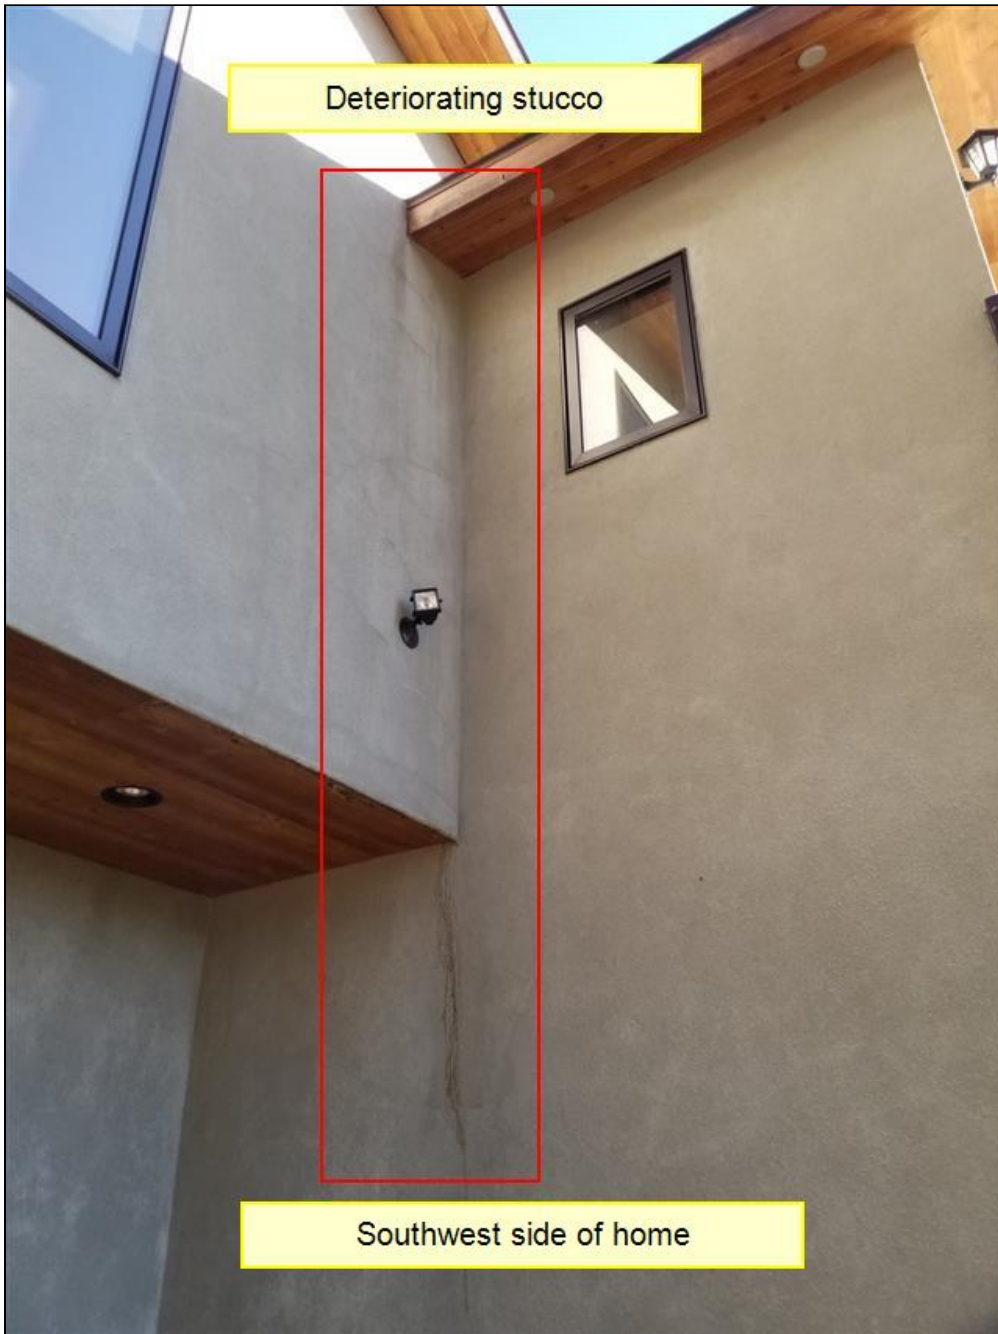
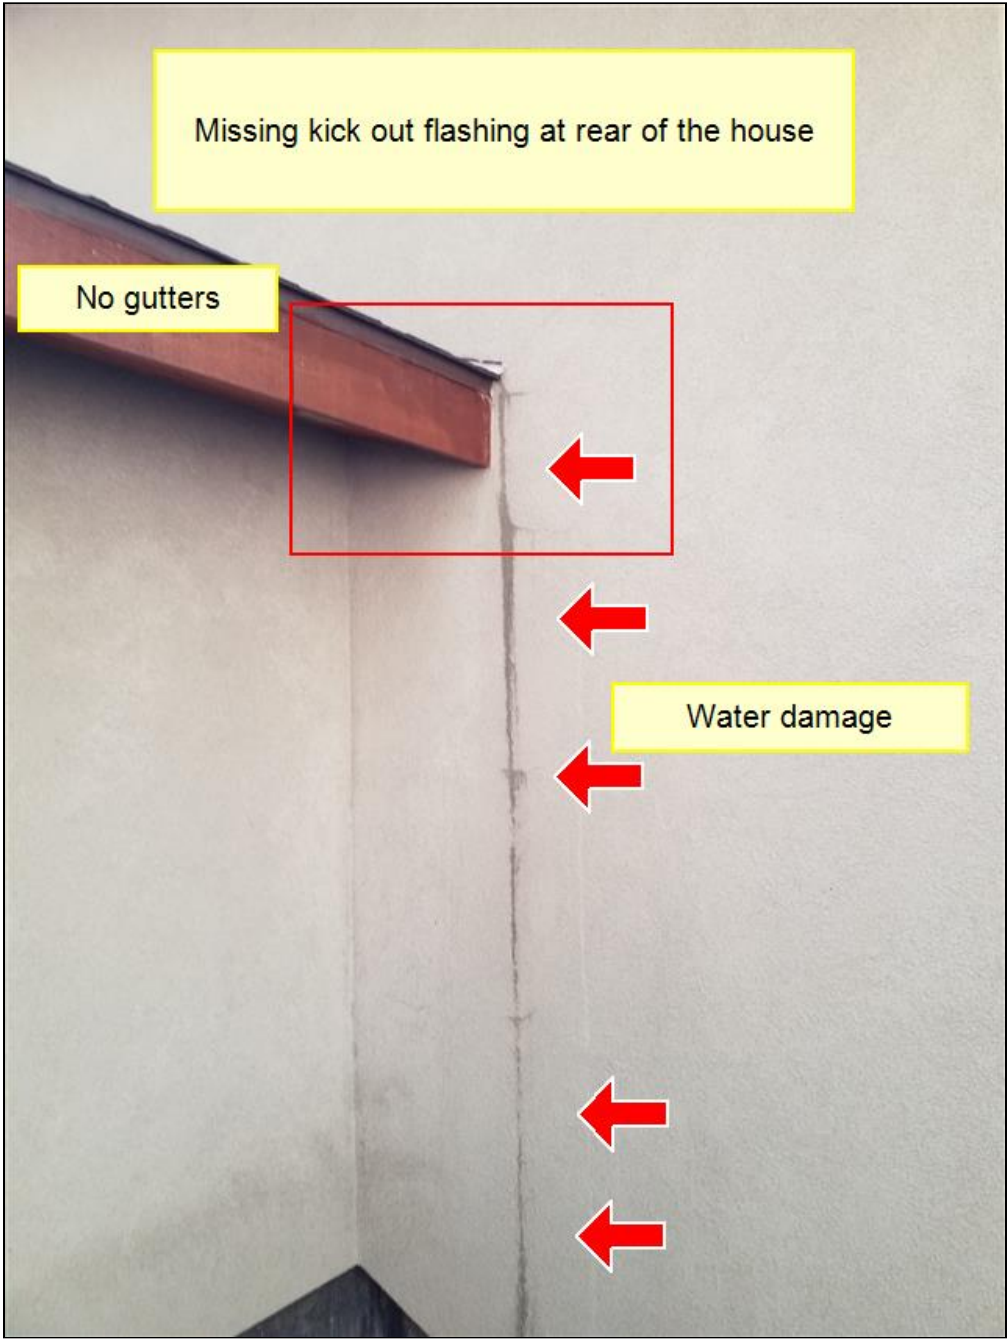
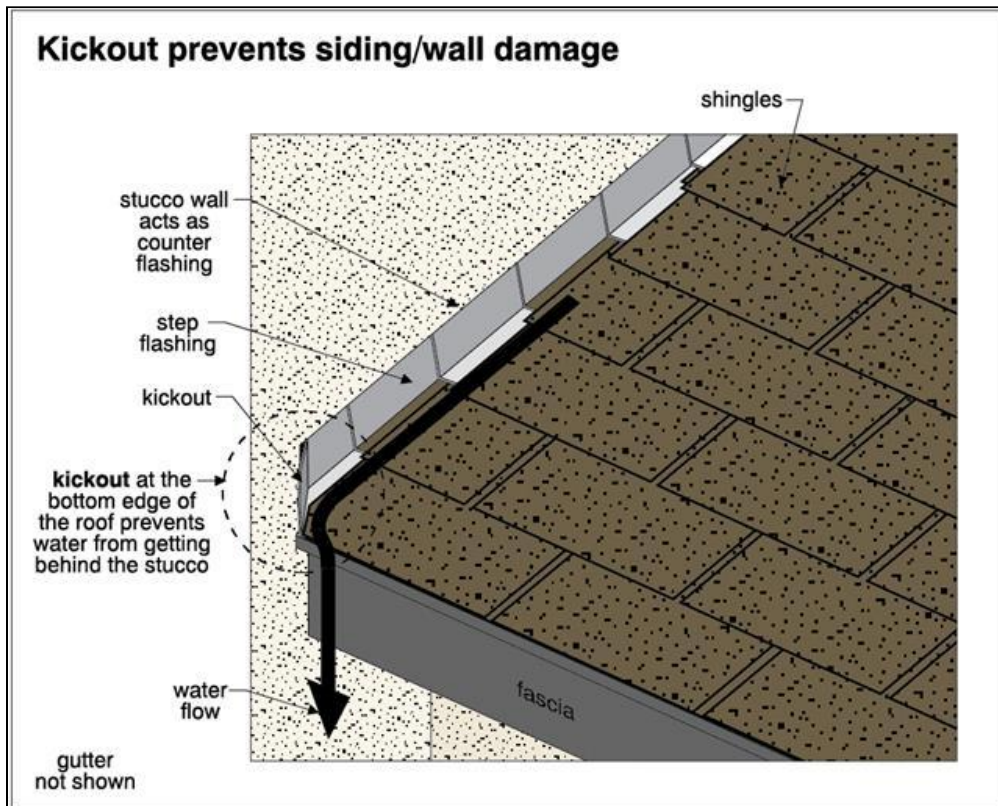
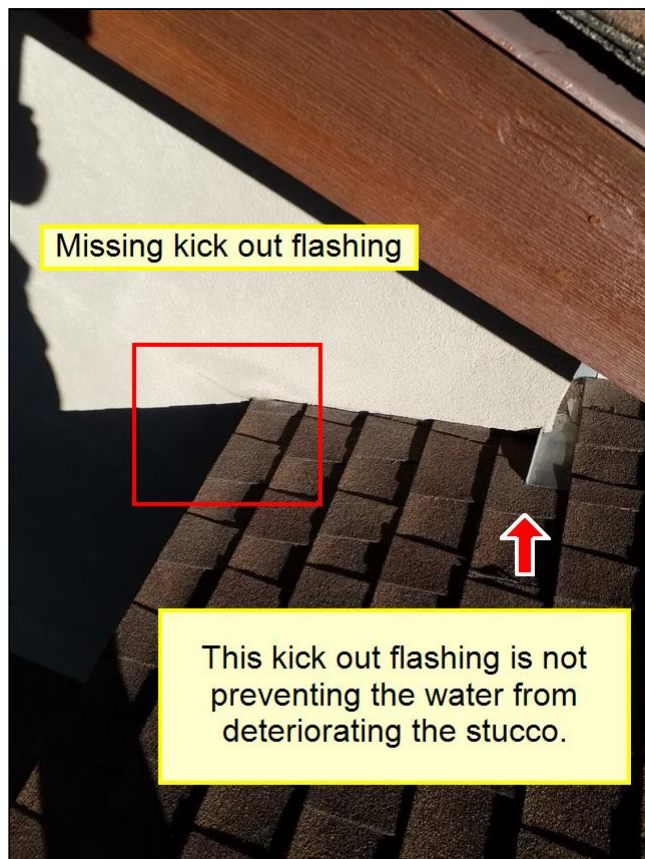
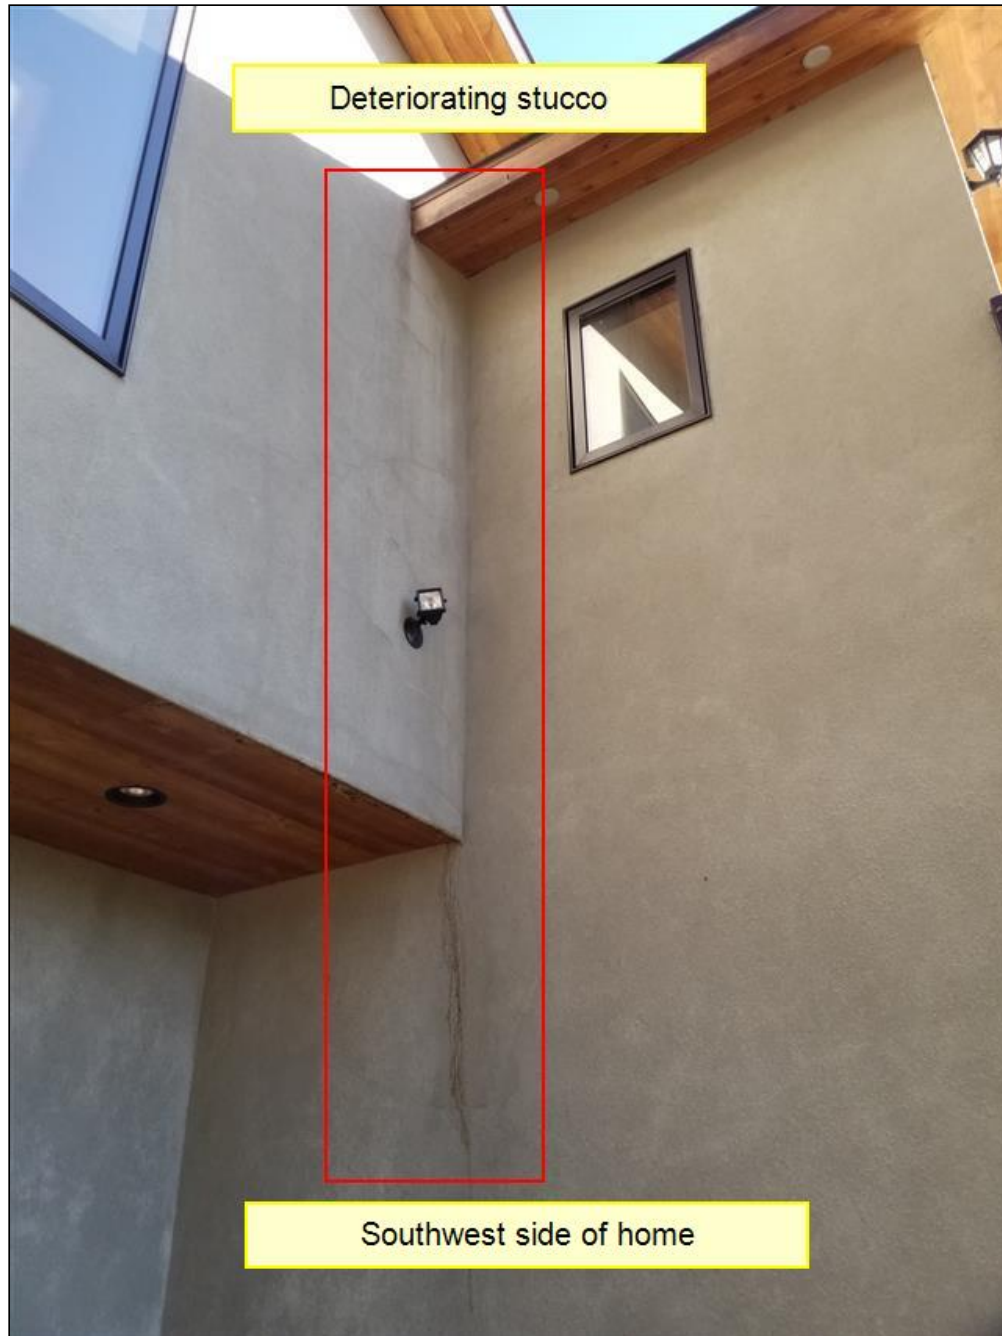
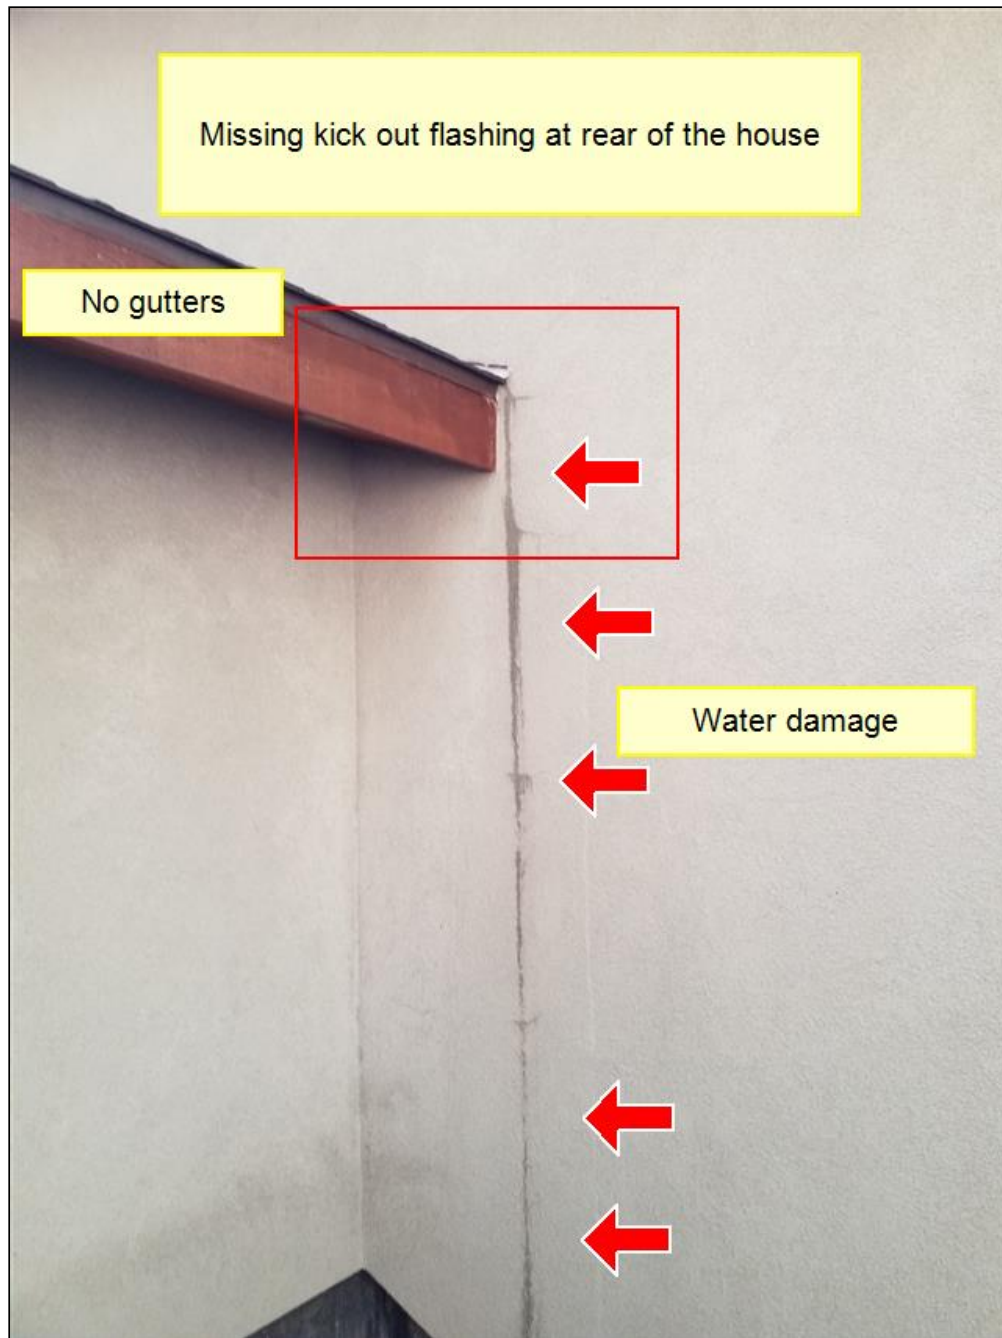
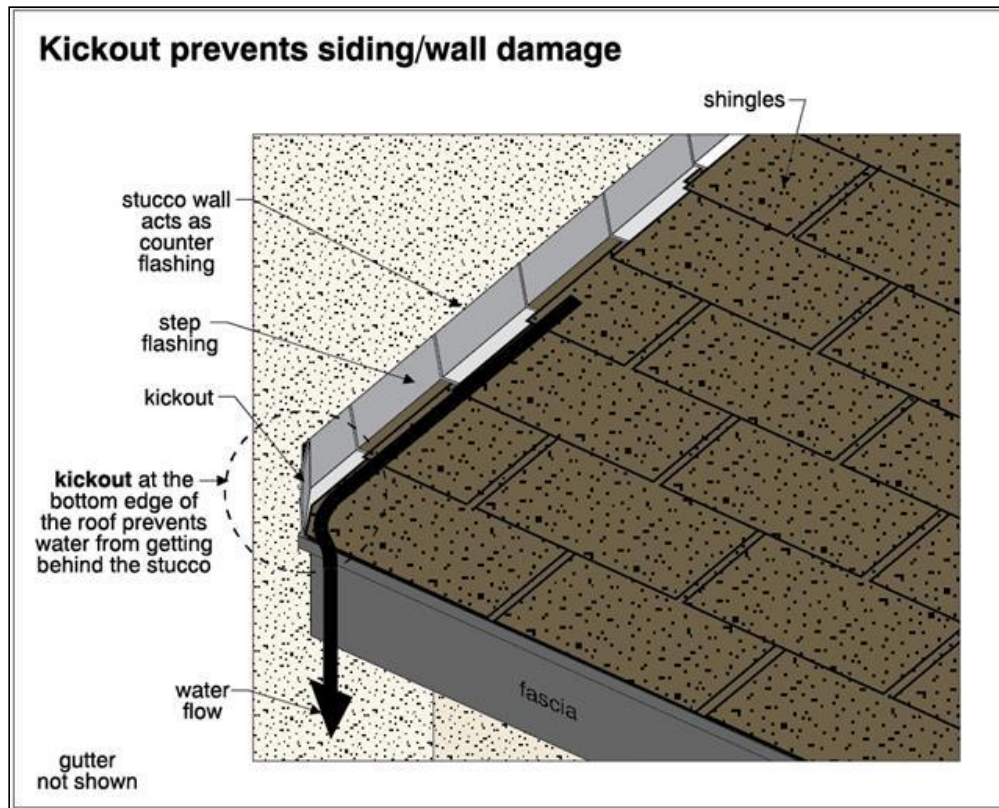
1.1 There are two areas that need proper kick out flashing to prevent water from deteriorating the stucco siding any further. If the flashing is not installed, the stucco siding will eventually deteriorate completely causing the stucco to fail. I recommend a licensed roofing or contractor to further evaluate and repair as needed.

There are two areas that need proper kick out flashing to prevent water from deteriorating the stucco siding any further. If the flashing is not installed, the stucco siding will eventually deteriorate completely causing the stucco to fail. I recommend a licensed roofing or contractor to further evaluate and repair as needed.

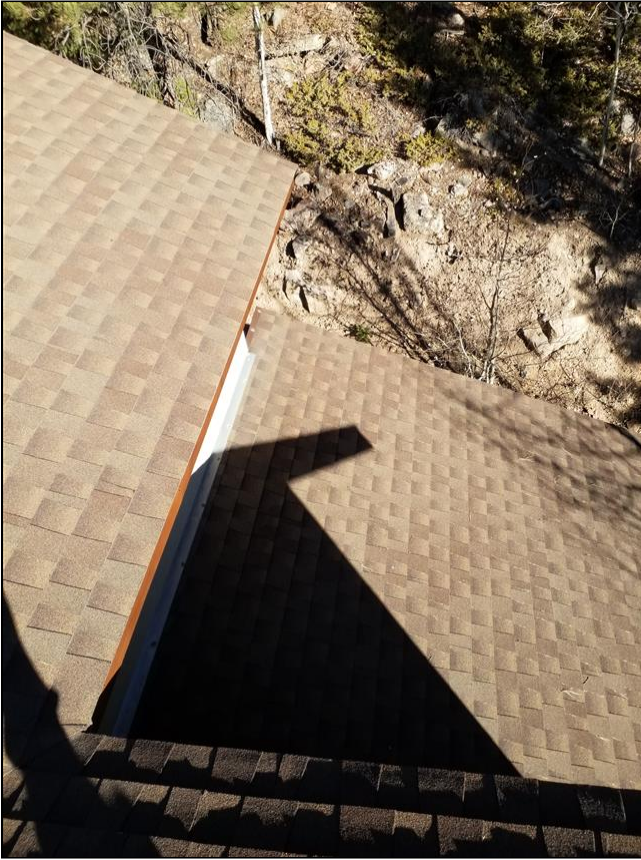
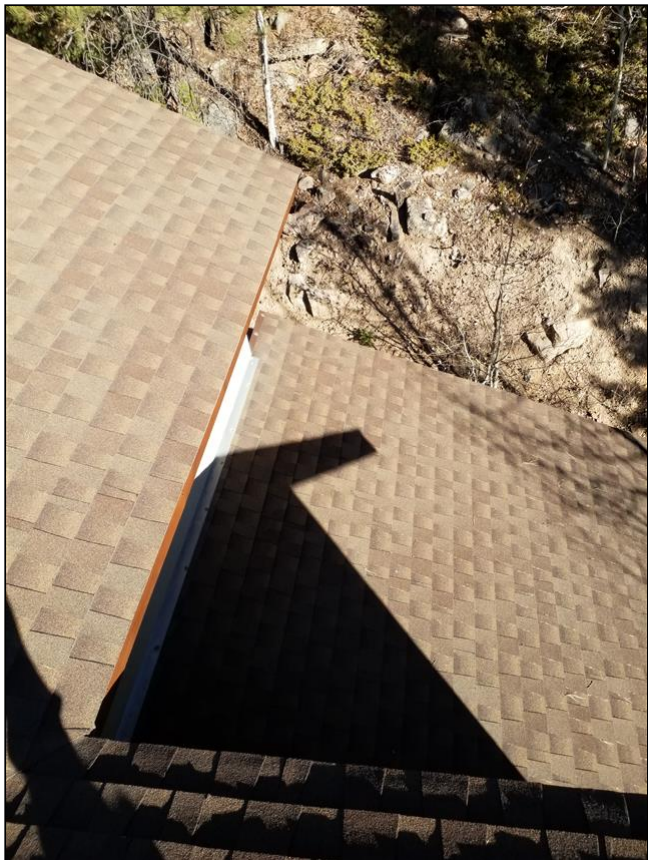
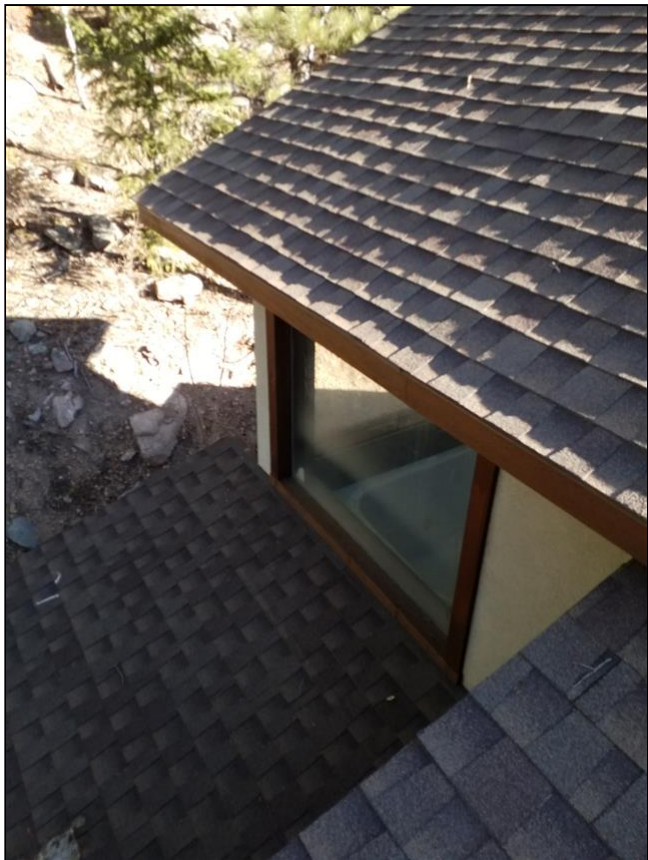
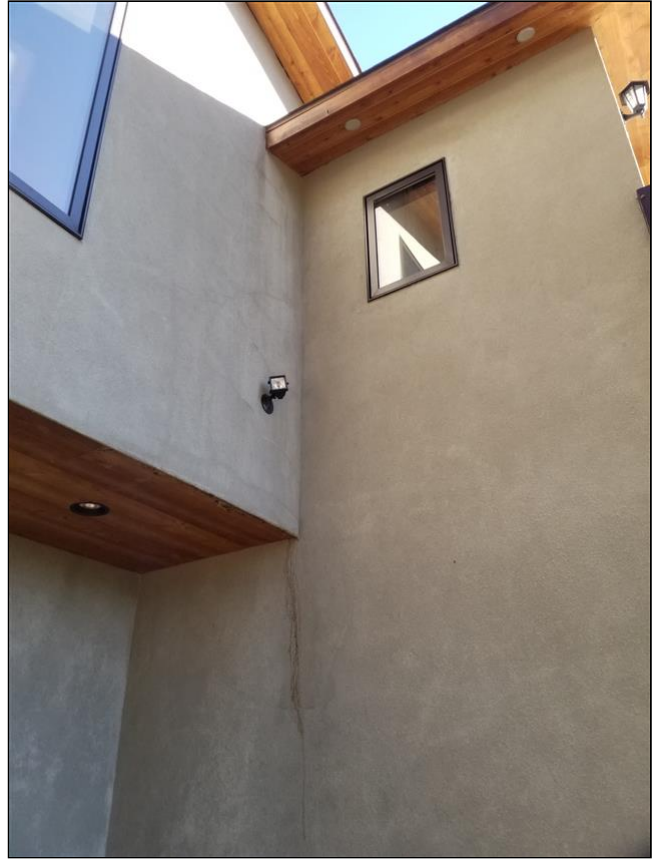
1.4 The house does have two gutters and downspouts that drain below grade. Additional gutters and downspouts would be beneficial in the front and rear of the home. Gutters help move water away from sensitive areas of the roof and control erosion around the foundation. I recommend having gutters installed by a qualified person or company.

The house does have two gutters and downspouts that drain below grade. Additional gutters and downspouts would be beneficial in the front and rear of the home. Gutters help move water away from sensitive areas of the roof and control erosion around the foundation. I recommend having gutters installed by a qualified person or company.

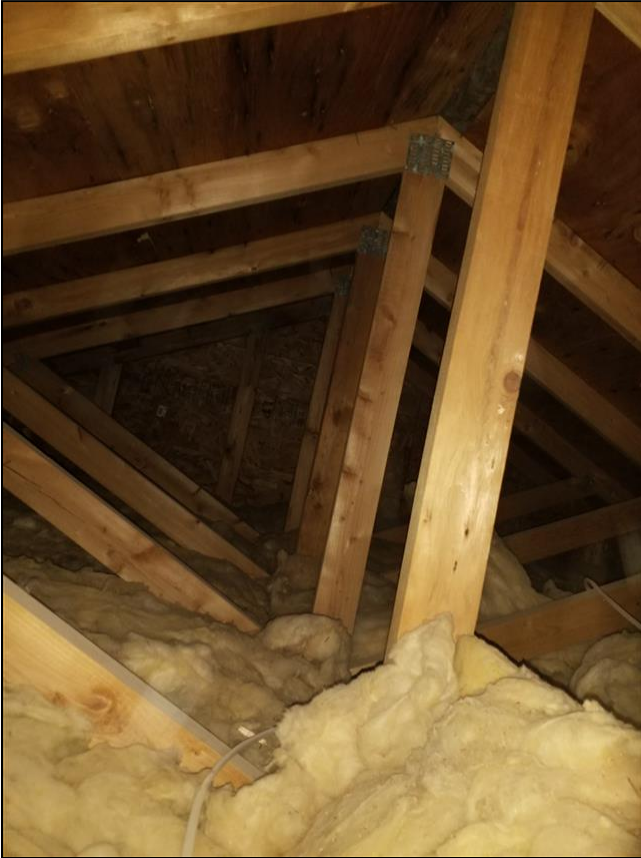
1.7 Item 1(Picture)

1.7 There is a small attic space over the master bathroom. Access for the attic is in the bathroom. Insulation level appears to be adequate.

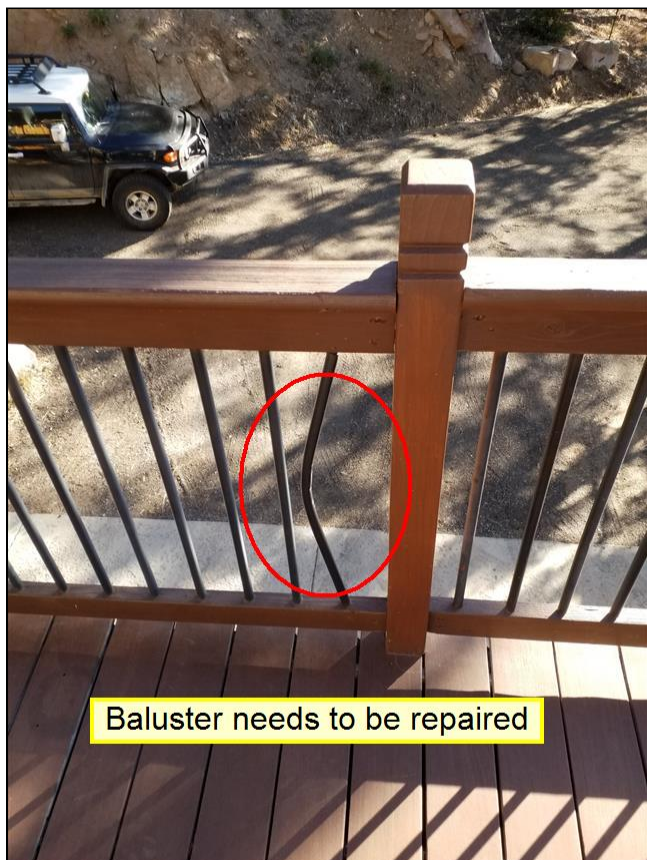
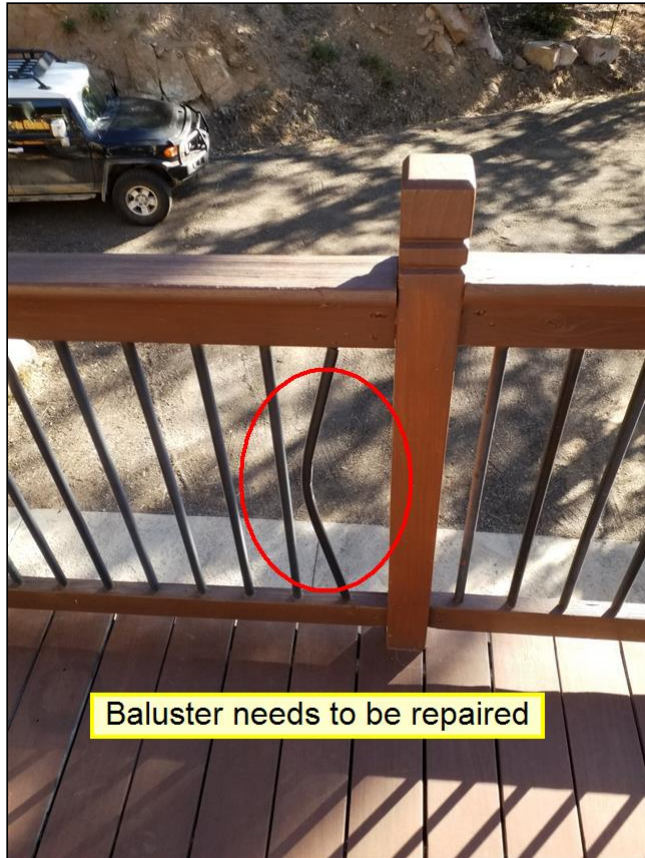
2.3 The guard rail facing the front of the house is unsafe. I do not believe the guard will would support a person leaning against it. I recommend a licensed contractor to further evaluate and repair as needed.

The guard rail facing the front of the house is unsafe. I do not believe the guard will support a person leaning against it. I recommend a licensed contractor to further evaluate and repair as needed.

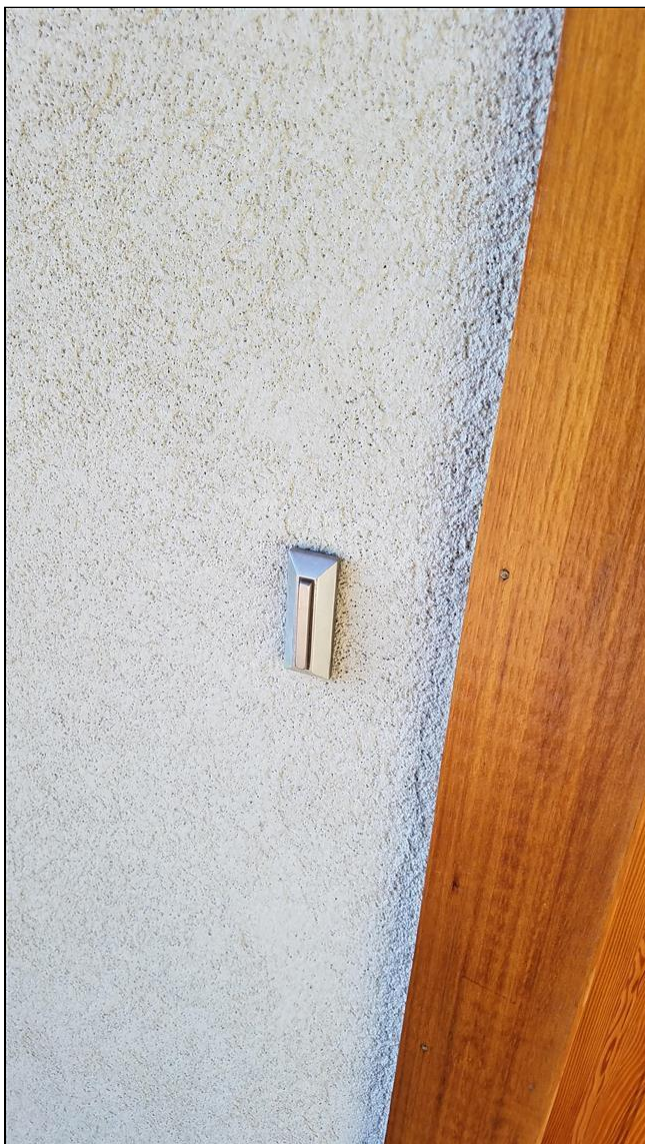
2.7 Item 1(Picture)

2.7 The doorbell did not work when tested. Recommend a qualified person to repair as needed.

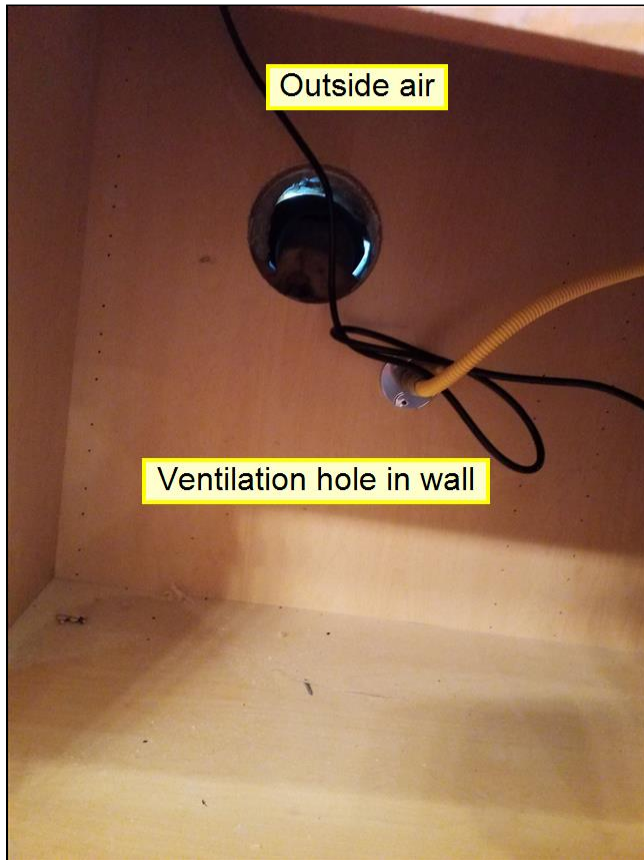
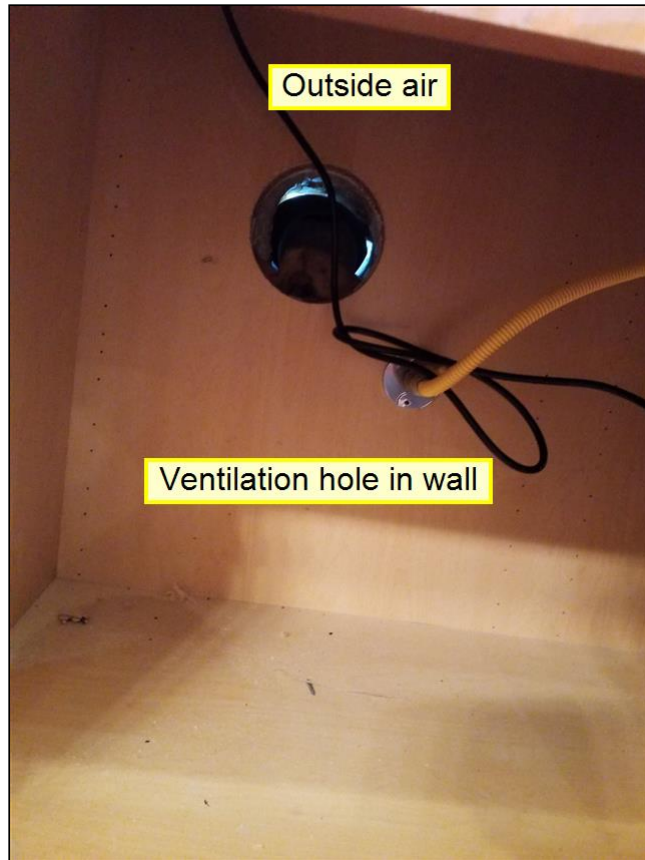
4.11 The ventilation for the range is not connected. There is also no blower motor for ventilation. Although it's not required to have a ventilation for a non-pilot light cooking top, the install of the gas cooking top is poorly done and incomplete. I recommend speaking to the homeowners to determine if the cooking top is complete or needs additional work.

The ventilation for the range is not connected. There is also no blower motor for ventilation. Although it's not required to have a ventilation for a non-pilot light cooking top, the install of the gas cooking top is poorly done and incomplete. I recommend speaking to the homeowners to determine if the cooking top is complete or needs additional work.

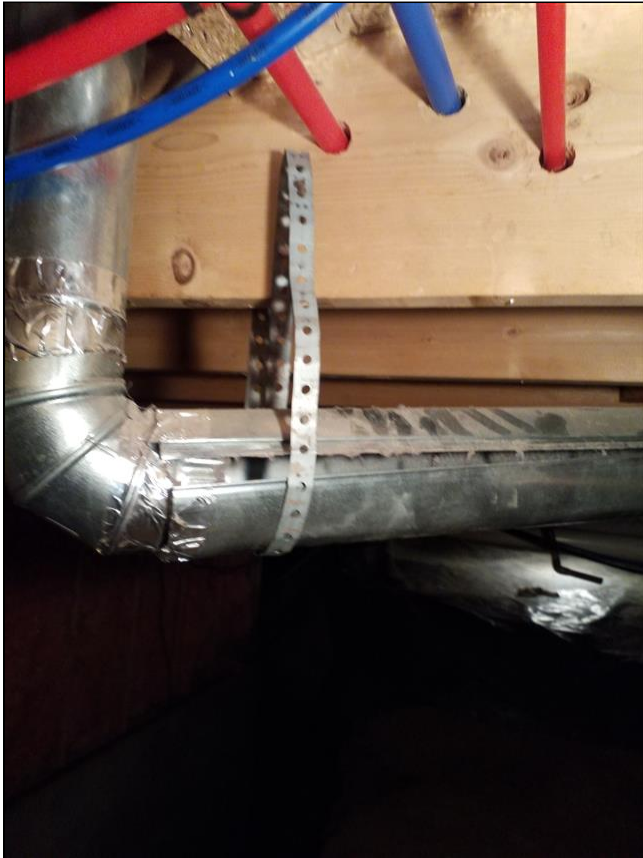
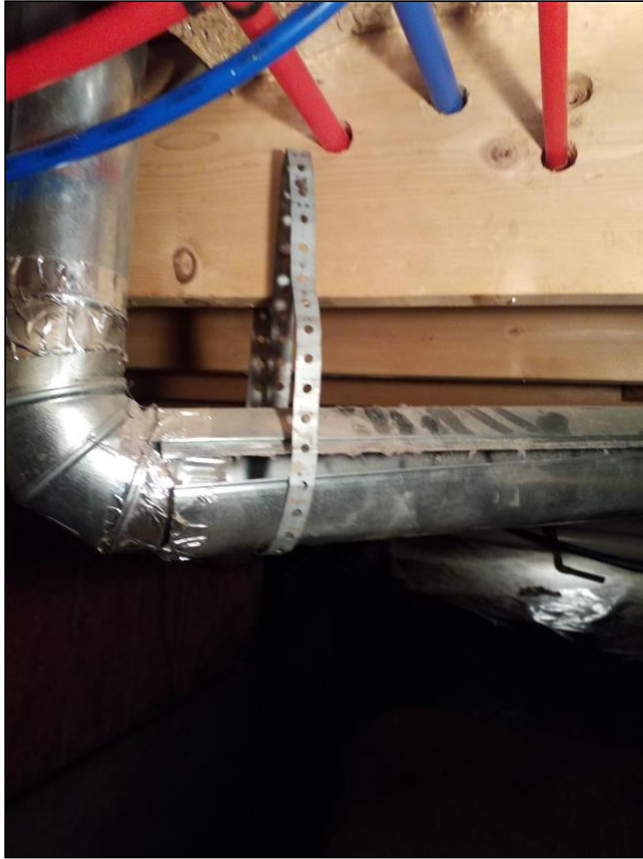
4.15 The dryer vent pipe in the crawlspace has come apart at the seam. This is allowing hot, moist air into the crawlspace instead to the exterior. I recommend a qualified person to repair as needed.

The dryer vent pipe in the crawlspace has come apart at the seam. This is allowing hot, moist air into the crawlspace instead to the exterior. I recommend a qualified person to repair as needed.

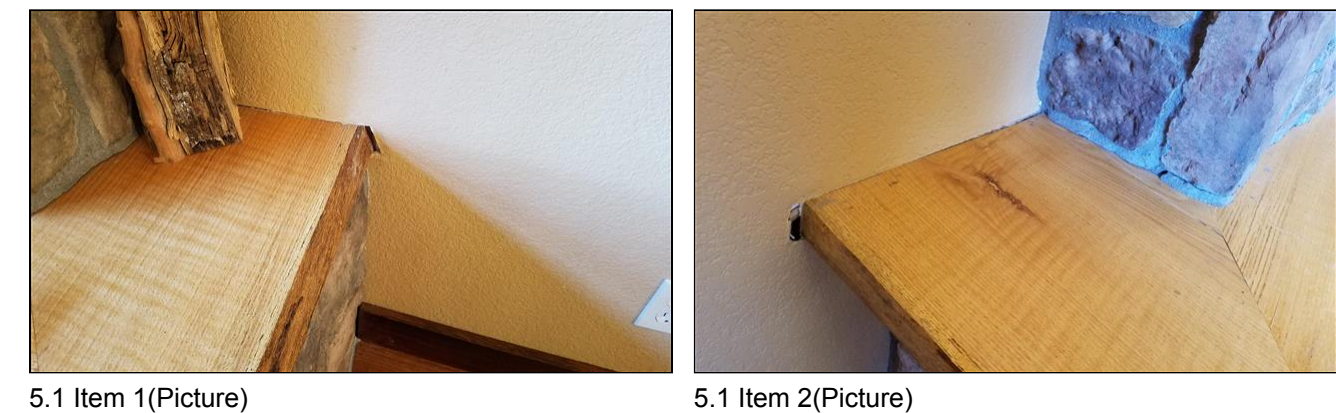
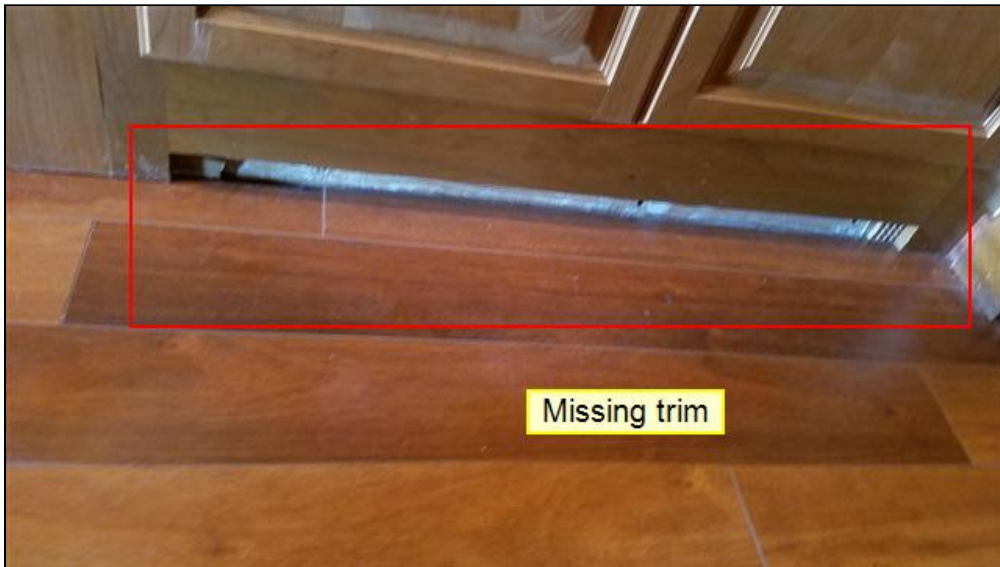
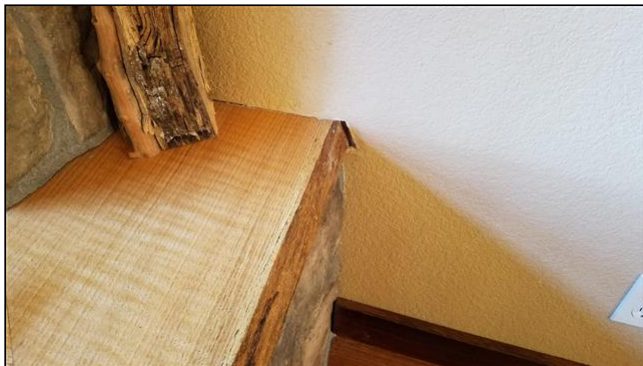
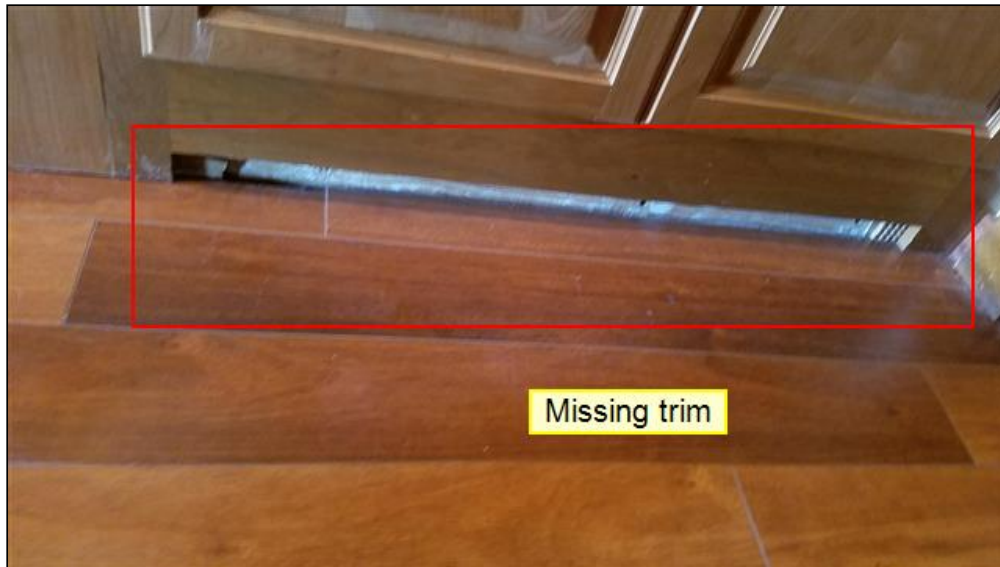
5.1 There is some drywall damage near the wooden hearth around the main floor fireplace. It appears that when the hearth was installed, the drywall needed to be cut for proper fitting. Some minor drywall repair work is needed in these areas. This does not appear to be completed and I recommend speaking to the homeowners for more information.

There is some missing trim from under the hallway cabinetry. I appears the work is not completed.

There is some drywall damage near the wooden hearth around the main floor fireplace. It appears that when the hearth was installed, the drywall needed to be cut for proper fitting. Some minor drywall repair work is needed in these areas. This does not appear to be completed and I recommend speaking to the homeowners for more information.

There is some missing trim from under the hallway cabinetry. It appears the work is not completed.

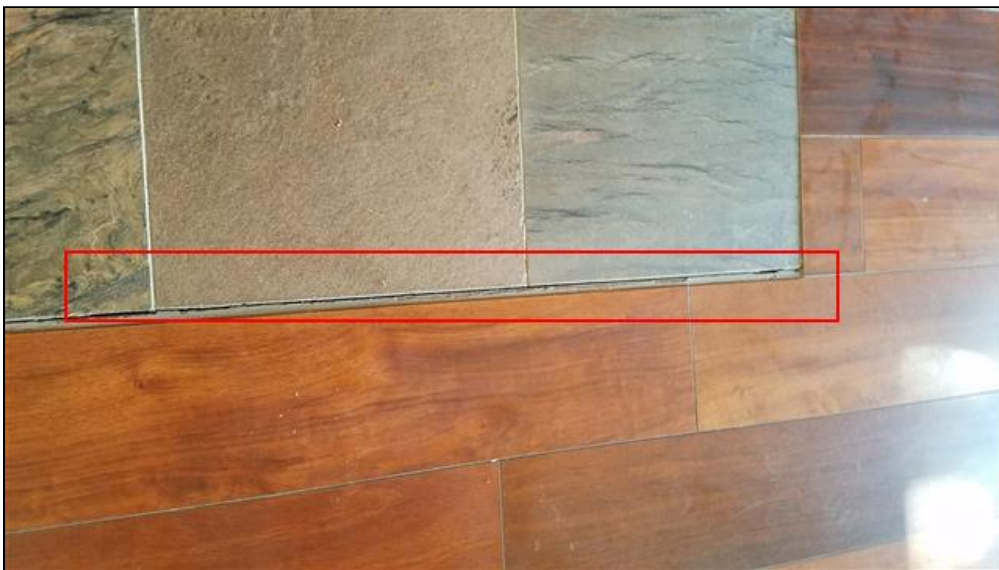
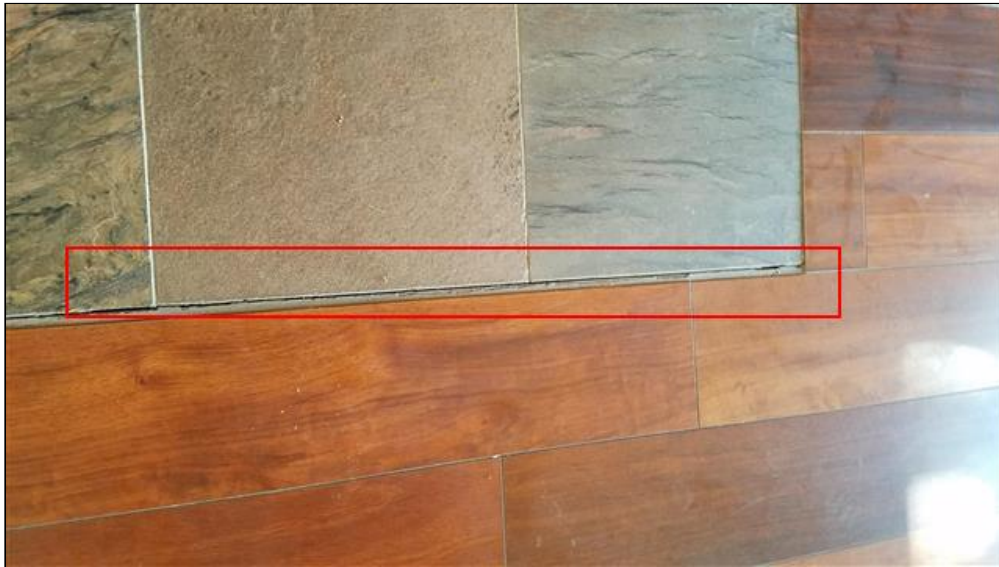
5.2 At the tile and floor transition at the entranceway, the grout is missing and/or cracking. Although this is cosmetic, the cost of repair should be considered.

At the tile and floor transition at the entranceway, the grout is missing and/or cracking. Although this is cosmetic, the cost of repair should be considered.

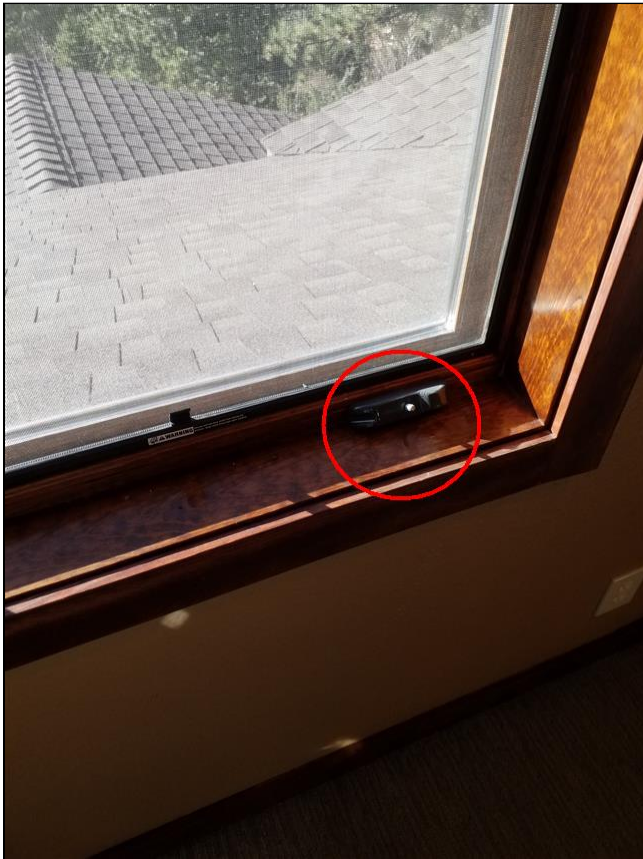
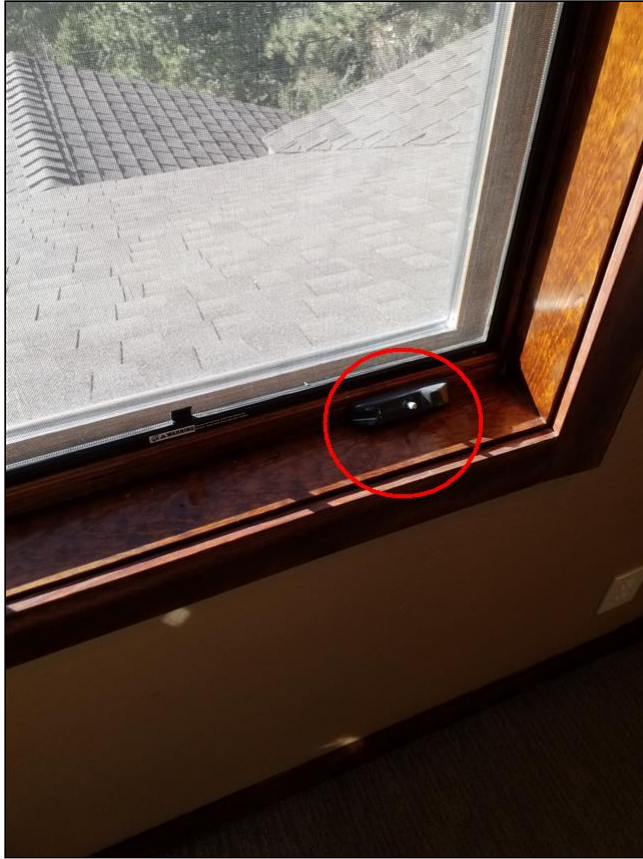
5.5 Master bedroom window missing crank handle.

Master bedroom window missing crank handle.

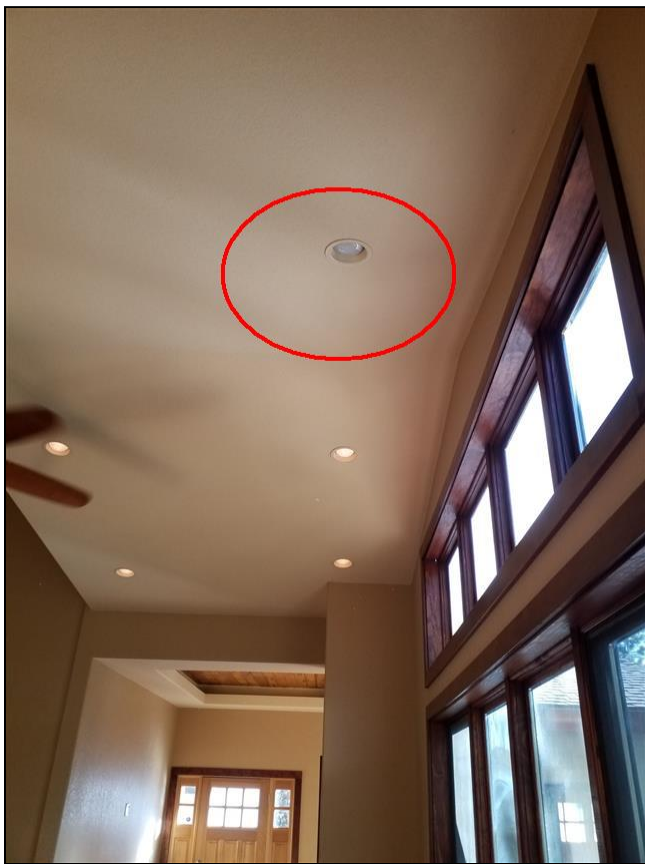
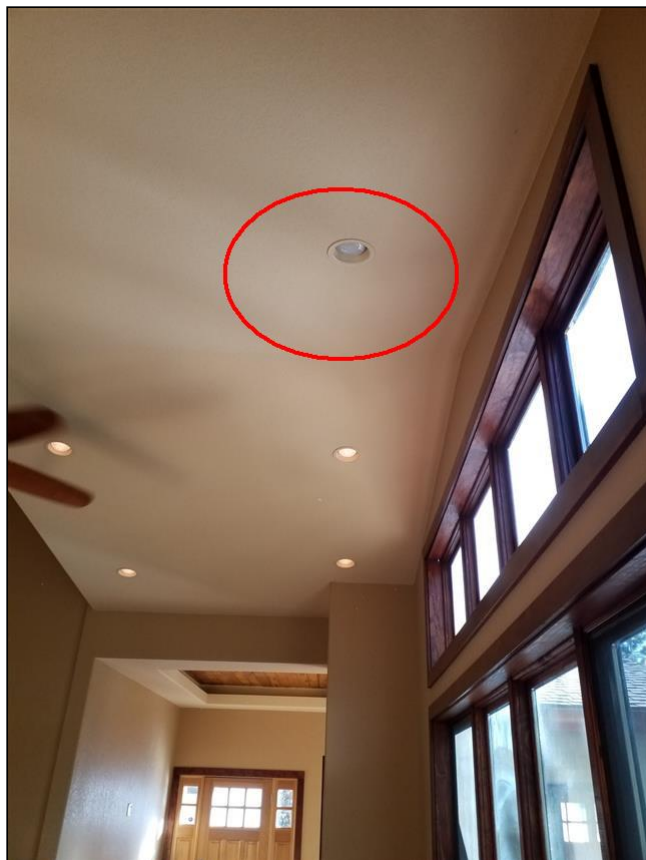
5.6 (1) There was one light out in the a living room ceiling. I assume the lightbulb is burnt out. I recommend having the homeowners replace the lightbulb to verify it works.

(1) There was one light out in the a living room ceiling. I assume the lightbulb is burnt out. I recommend having the homeowners replace the lightbulb to verify it works.
