Inspection Report

Property Address:
31468 King Valley West
Conifer CO 80433

Liberty Home Inspections, LLC

Date: 11/18/2019	Time: 09:00 AM	Report ID: 20191118-31468-King-Valley-West
Property: 31468 King Valley West Conifer CO 80433	Customer: Daniel Holton	Real Estate Professional: Lynn Westfall

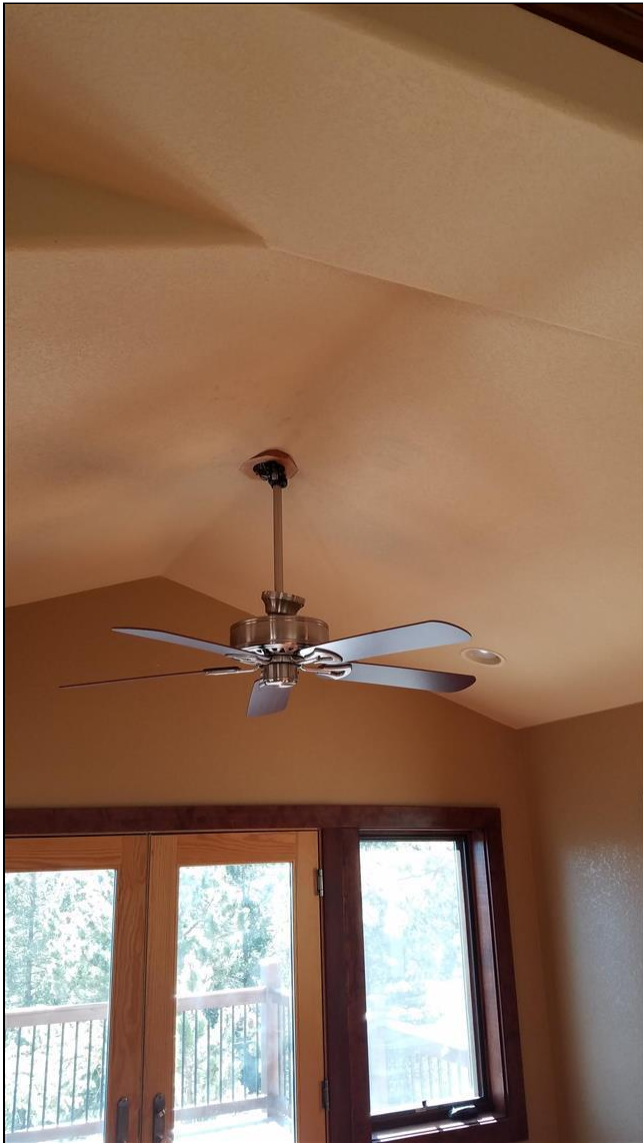
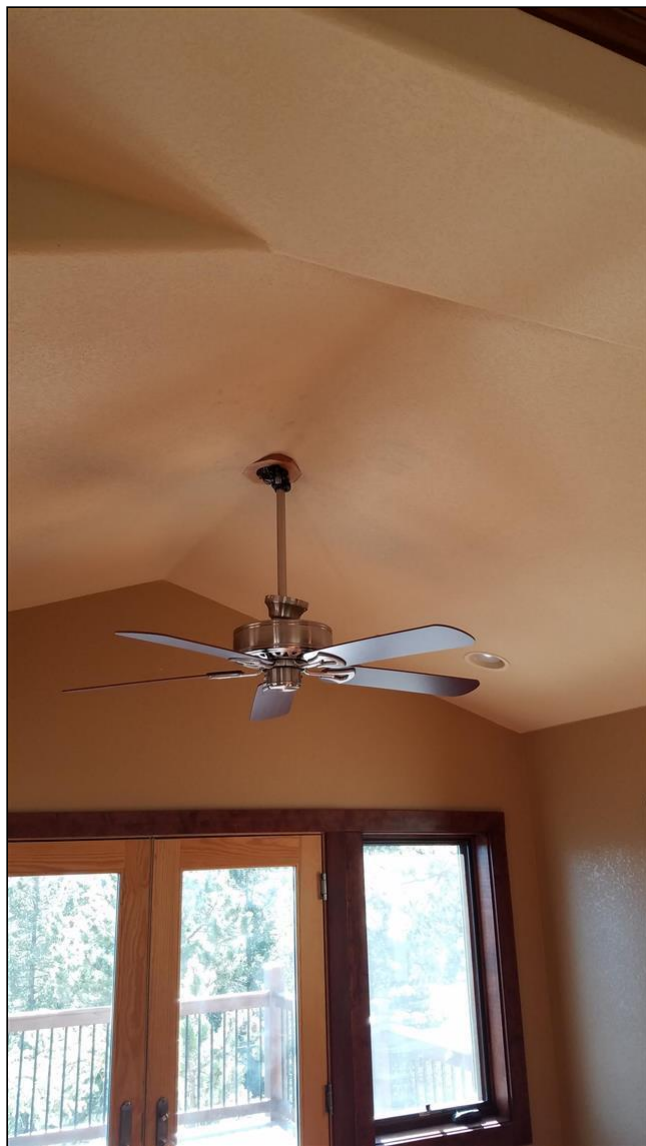
(2) The ceiling fan in the entryway is unbalanced and difficult to control due to the small pull chain. Also, there is a light switch labeled "Ceiling Fan Light" but neither ceiling fans on the main floor has a light fixture. I recommend speaking to the homeowners for more information regarding the light switch and have the fan properly installed by qualified person.

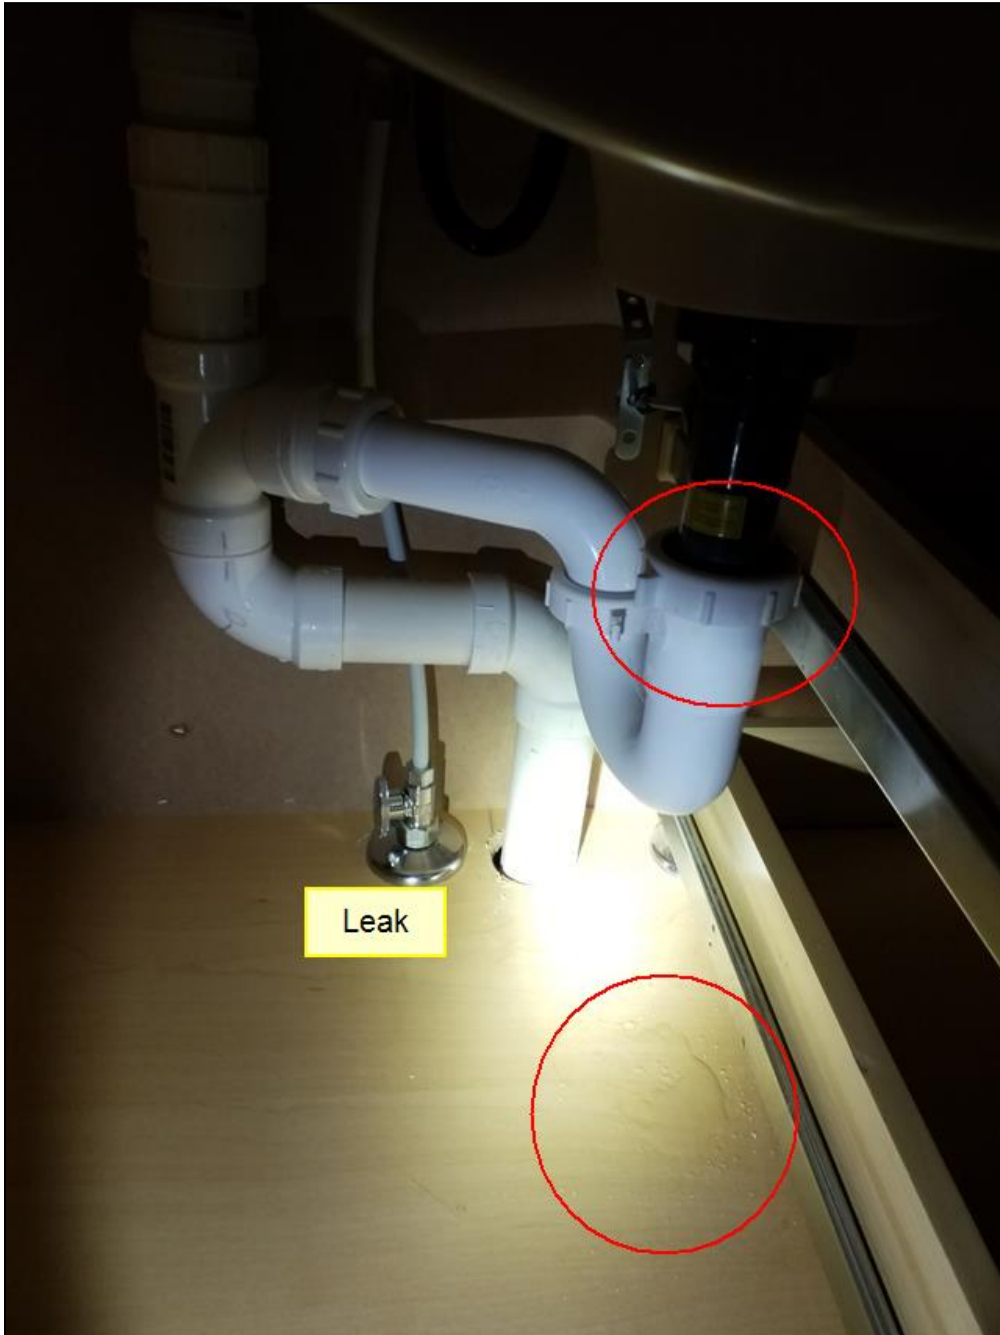
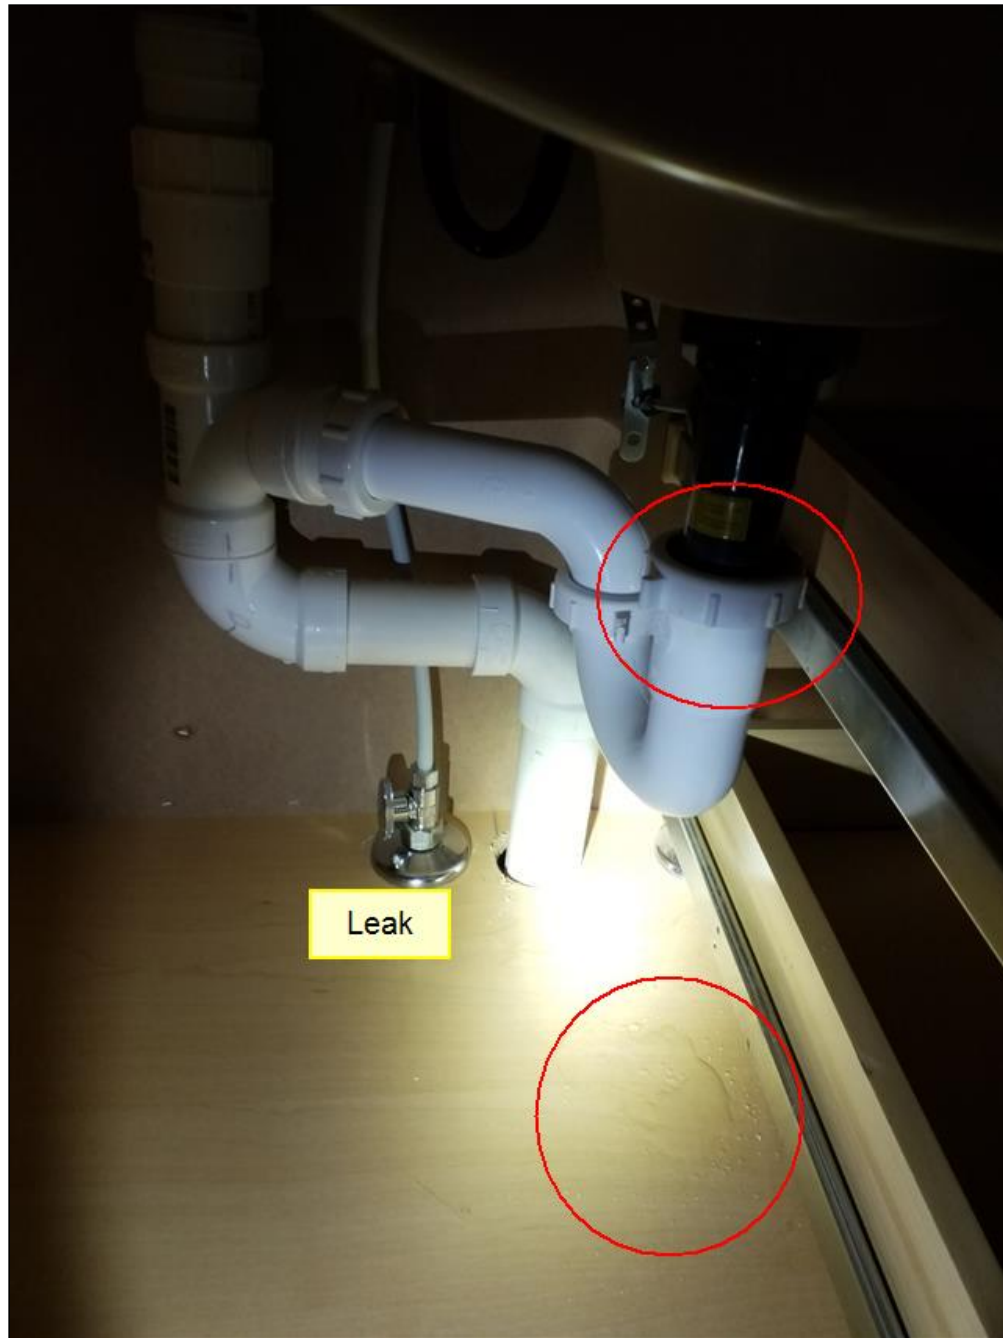
6.6 A leak was detected in the bathroom sink of the north guest bedroom. The leak appears to be coming from the tailpiece of the sink drain. I recommend a qualified person to repair as needed

A leak was detected in the bathroom sink of the north guest bedroom. The leak appears to be coming from the tailpiece of the sink drain. I recommend a qualified person to repair as needed

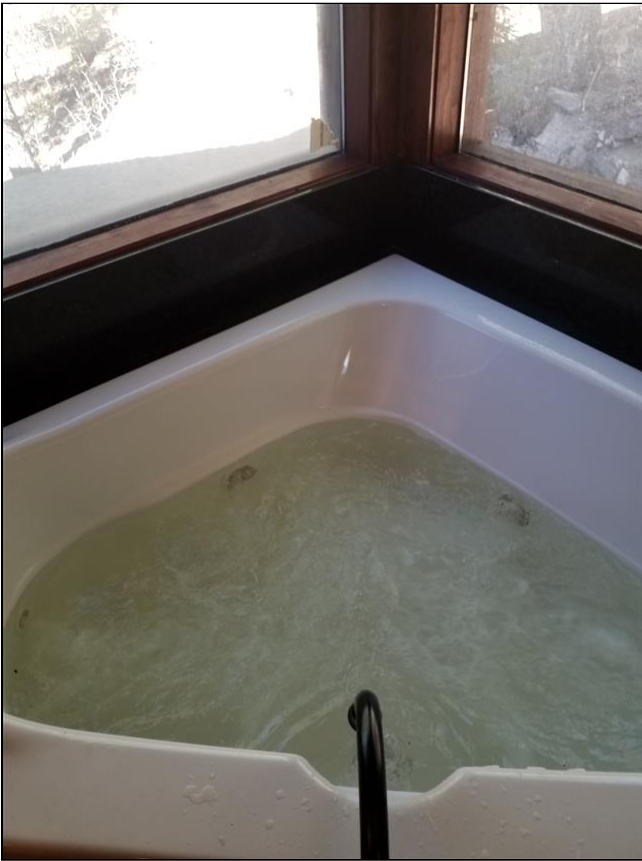
6.7 Item 1(Picture)

6.7 The jet tub in the master bedroom operated with no issues at the time of the inspection.

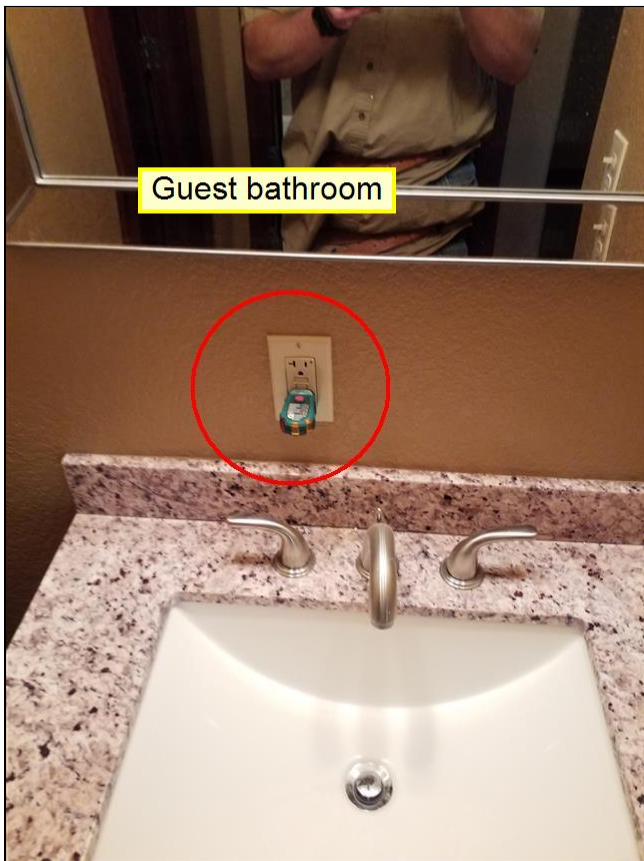
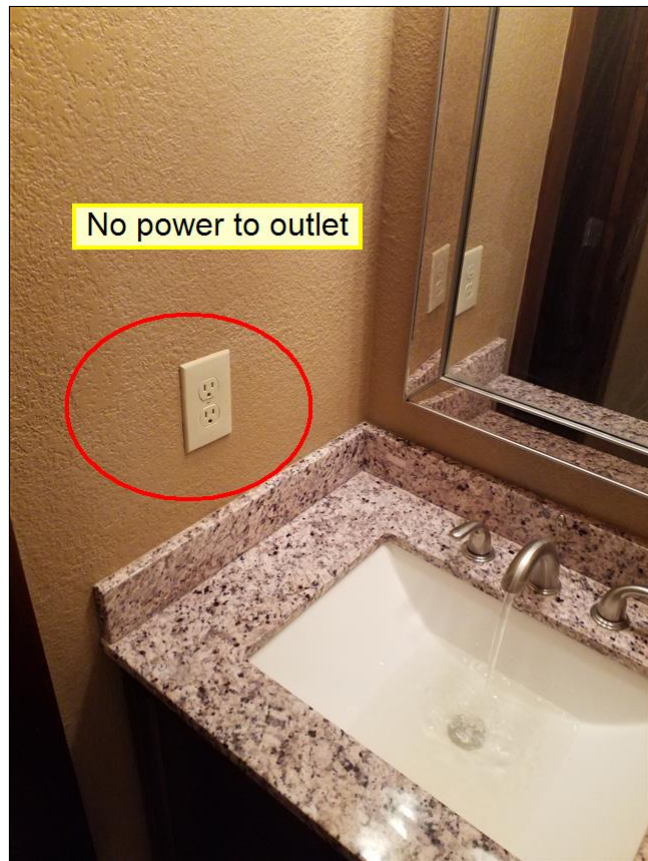
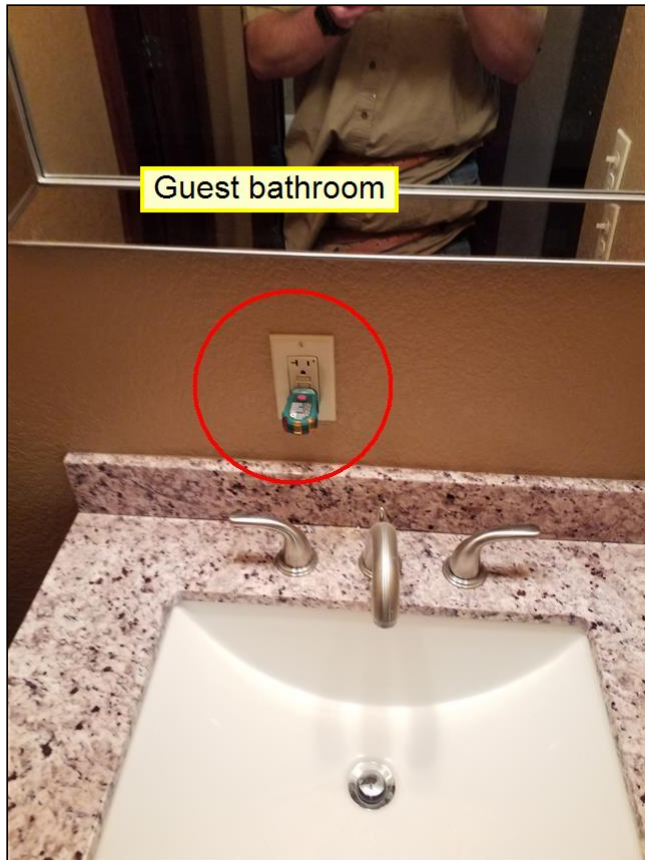
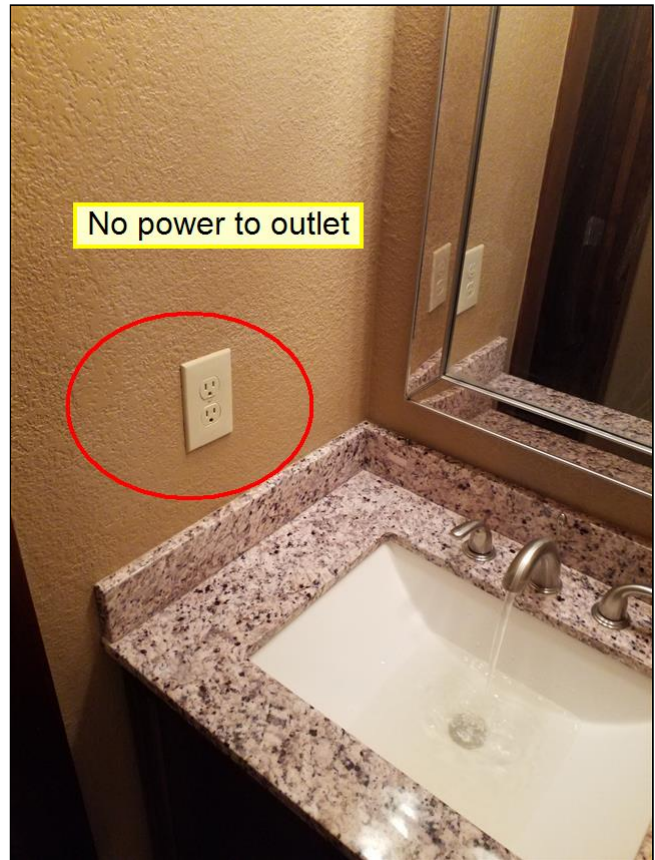
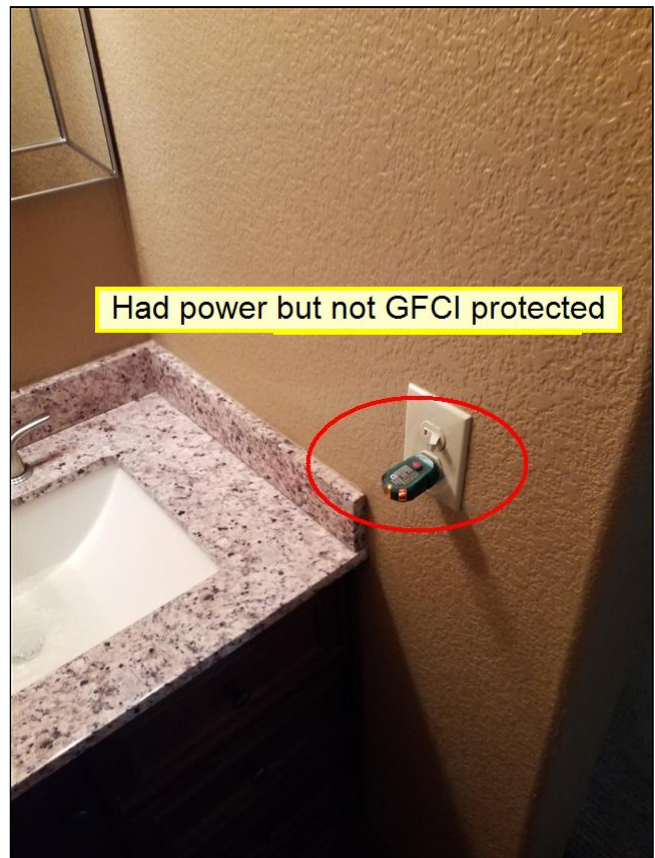
6.8 The GFCI outlet in the guest bathroom had no power going to it. It's possible the GFCI is defective and would not reset. It appears this GFCI outlet also protects the other outlets in the guest bathrooms/powder room. Those outlets did not have power going to them either indicating the GFCI was tripped. I recommend a licensed electrician to further evaluate and repair as needed.

The GFCI outlet in the guest bathroom had no power going to it. It's possible the GFCI is defective and would not reset. It appears this GFCI outlet also protects the other outlets in the guest bathrooms/powder room. Those outlets did not have power going to them either indicating the GFCI was tripped. I recommend a licensed electrician to further evaluate and repair as needed.

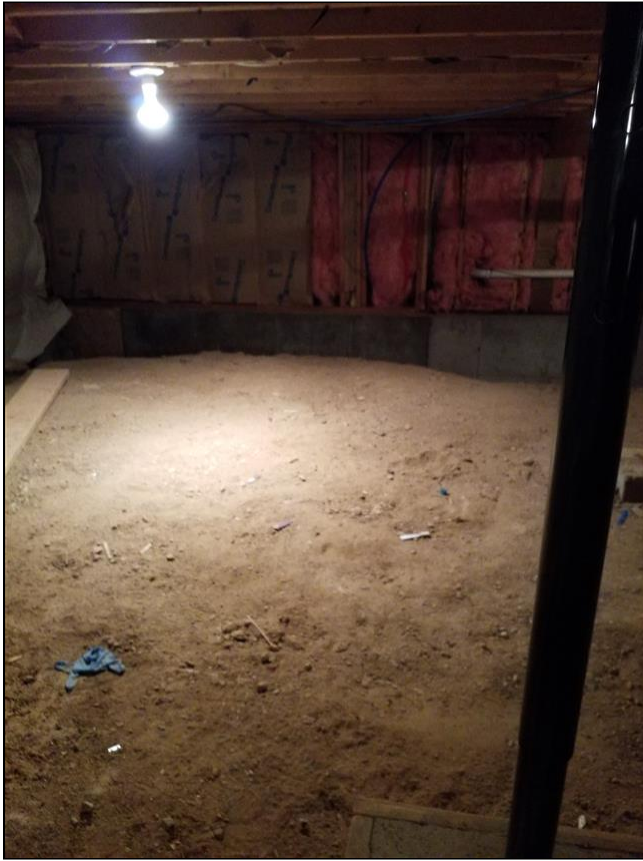
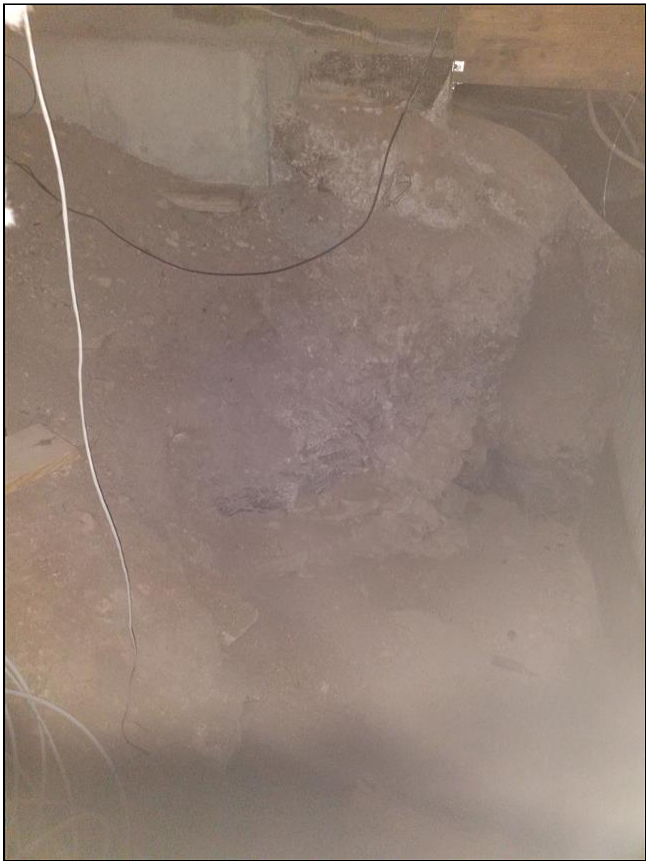
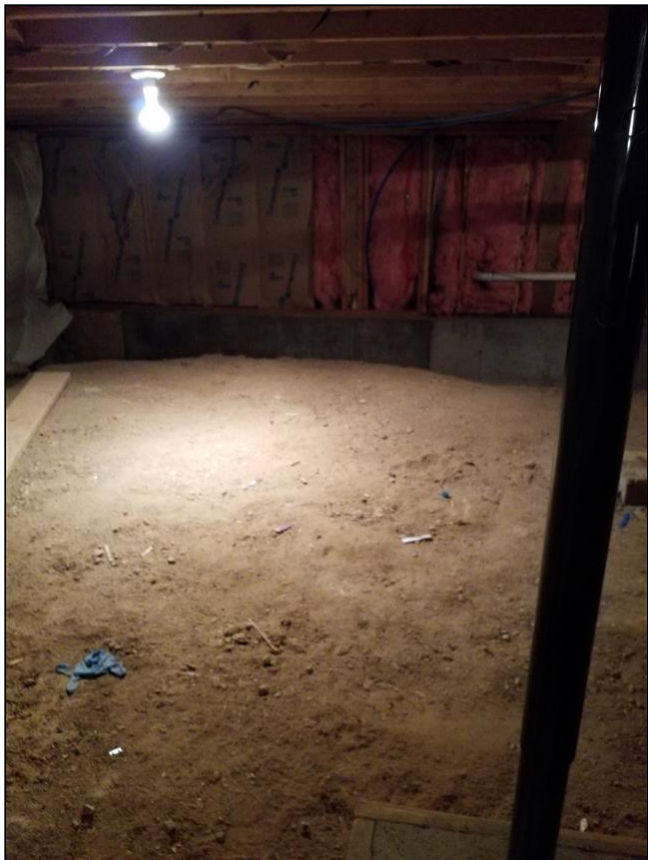
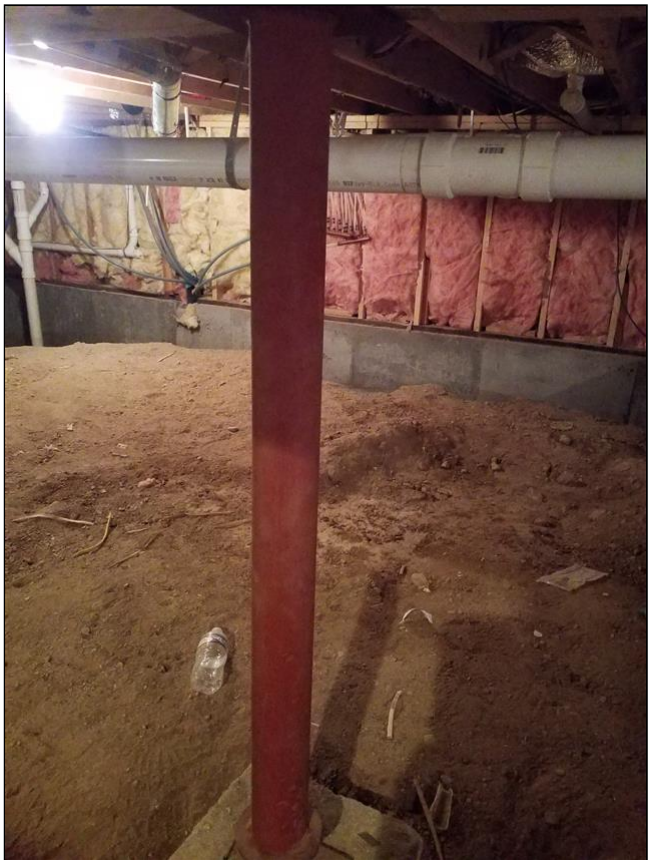
7.6 The vapor barrier (plastic) on the crawlspace ground is missing in areas. A vapor barrier provides added protection to the floor system from moisture or dampness that can enter from ground. A qualified person should repair or replace as needed.

The vapor barrier (plastic) on the crawlspace ground is missing in areas. A vapor barrier provides added protection to the floor system from moisture or dampness that can enter from ground. A qualified person should repair or replace as needed.

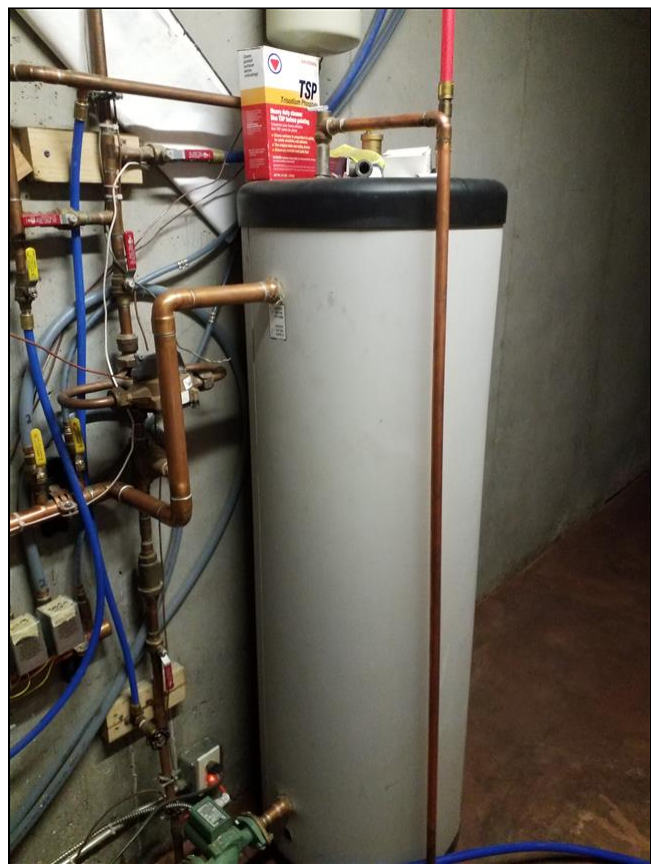
8.2 Item 1(Picture)

The house is equipped with an indirect hot water storage system. Heat for the water is supplied by the boiler system. I was unable to thoroughly inspect the hot water system due to the boiler system not operating correctly. I recommend a licensed HVAC company to further evaluate the indirect hot water storage system along with the boiler system.

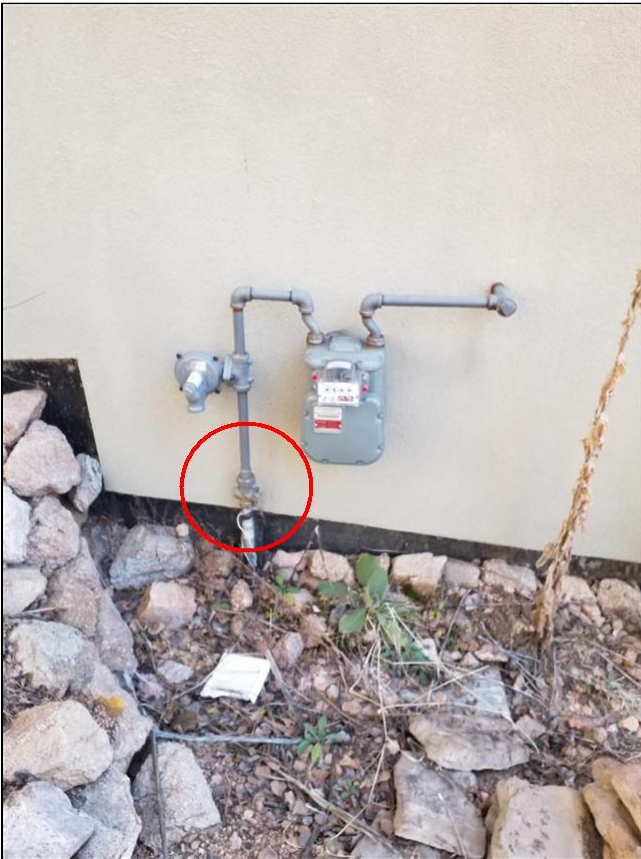
**8.5 Item 1(Picture)**

8.5 Main fuel shutoff is located at the meter.

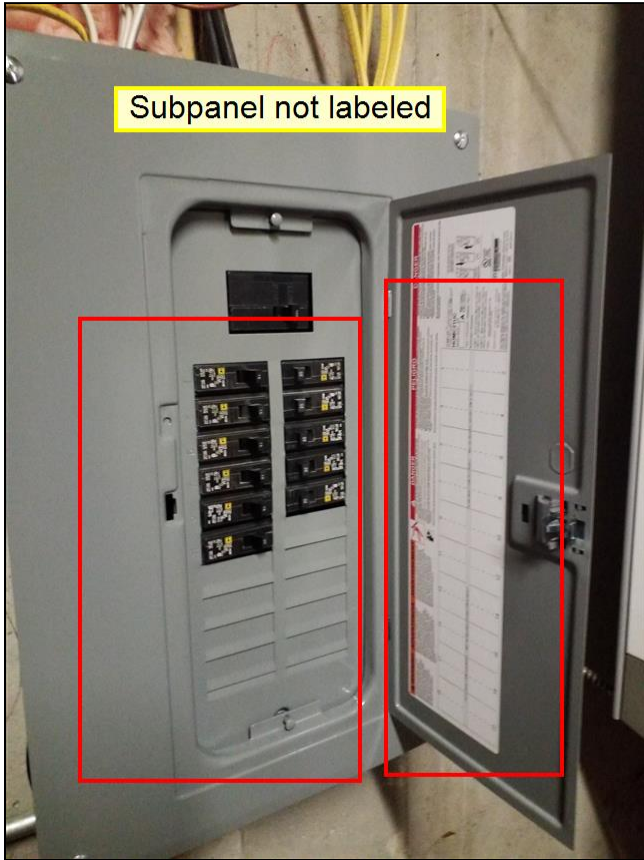
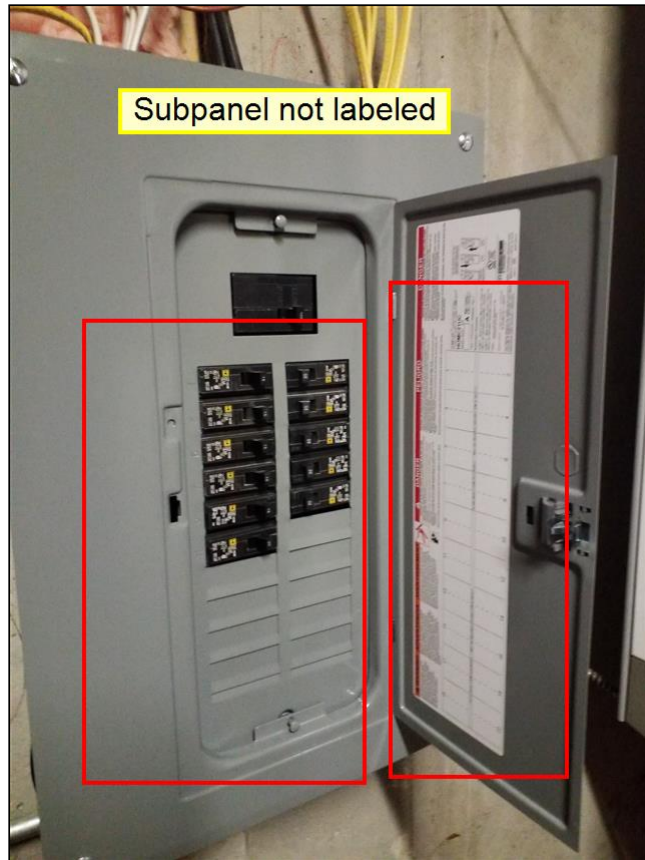
9.1 The subpanel in the mechanical room was not labeled. Labeling of the circuit breakers is required in the electrical code. I recommend a licensed electrician to label the subpanel correctly.

The subpanel in the mechanical room was not labeled. Labeling of the circuit breakers is required in the electrical code. I recommend a licensed electrician to label the subpanel correctly.

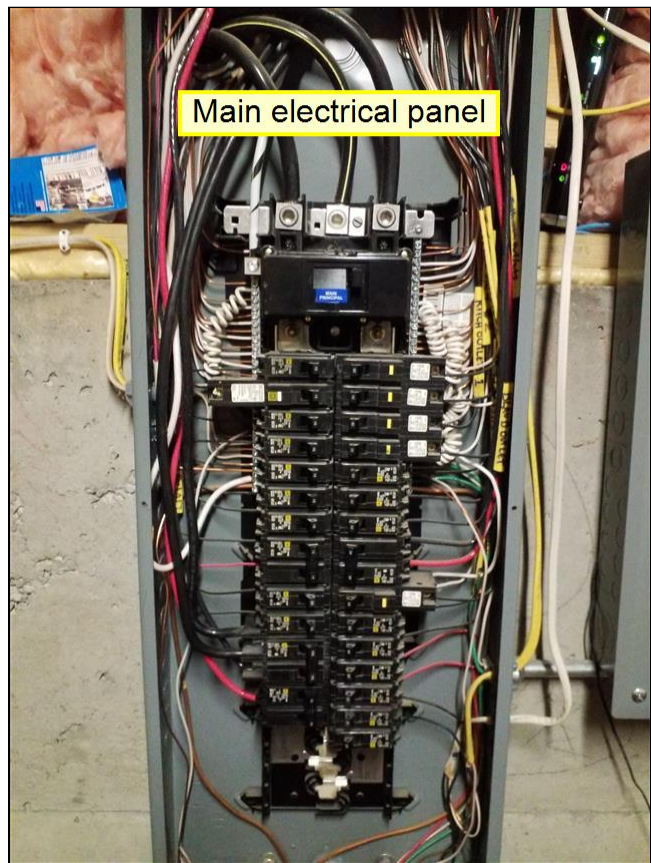
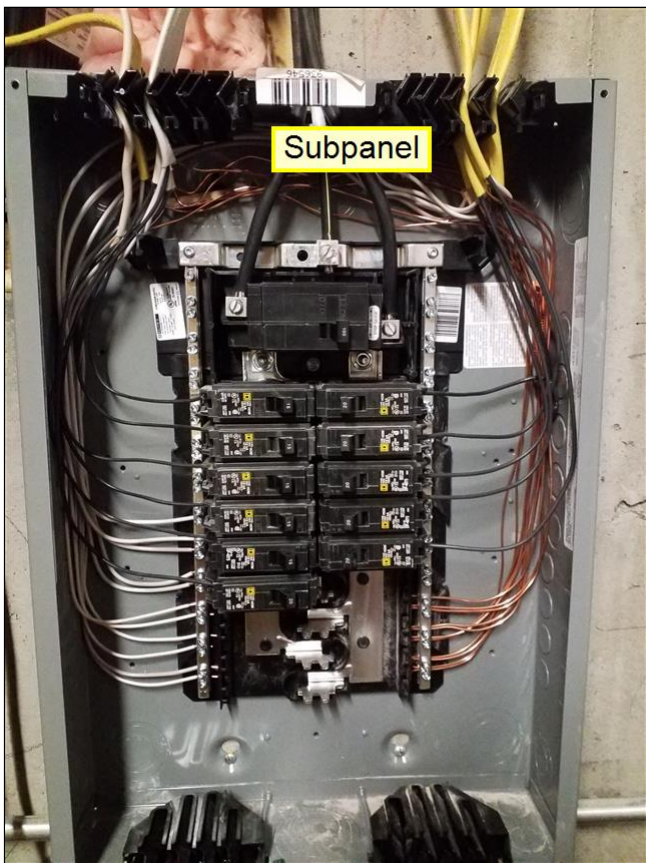
9.7 The main electrical panel and subpanel is located in the mechanical room.

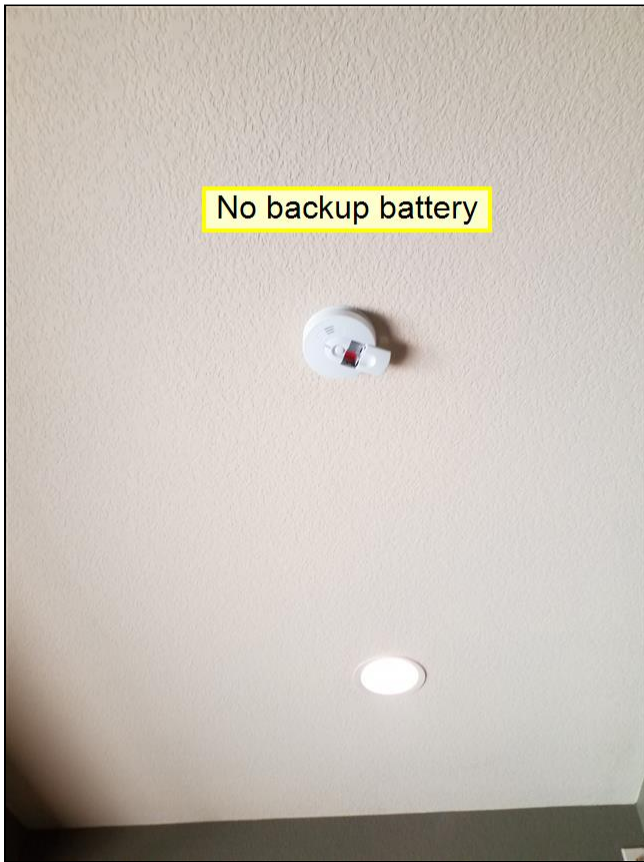
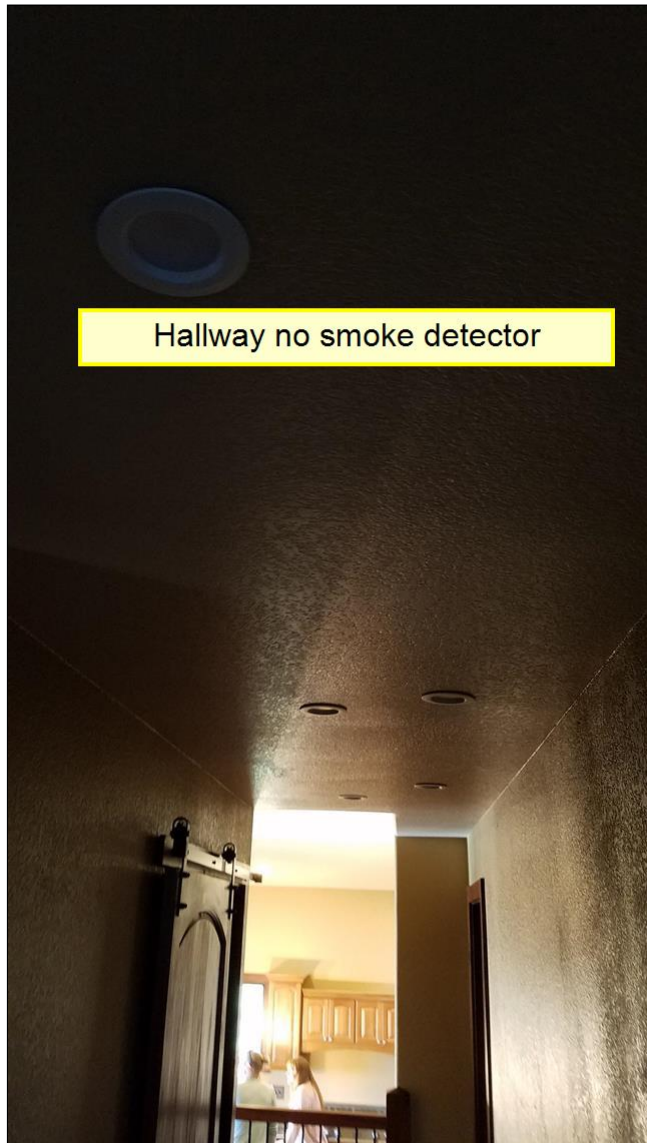
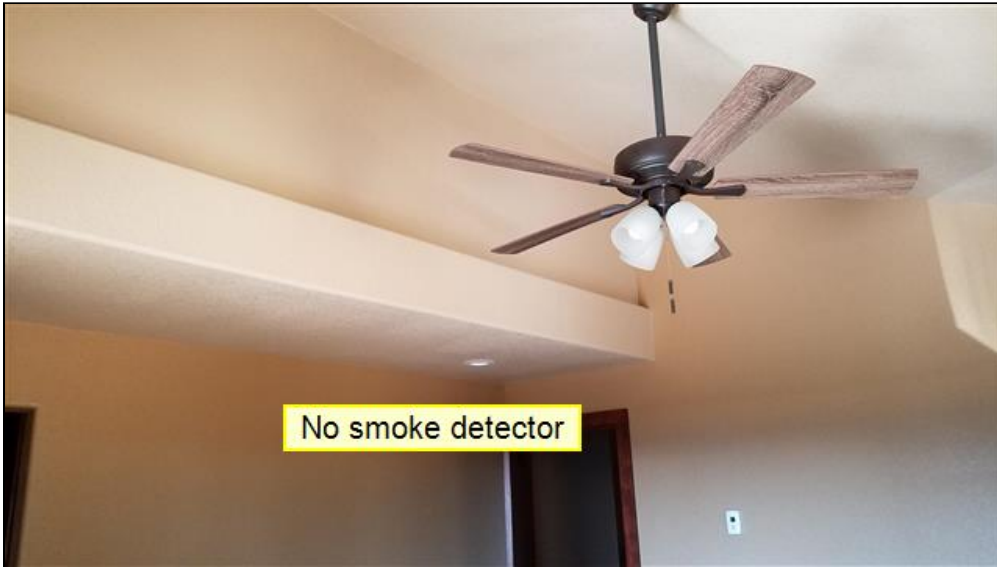
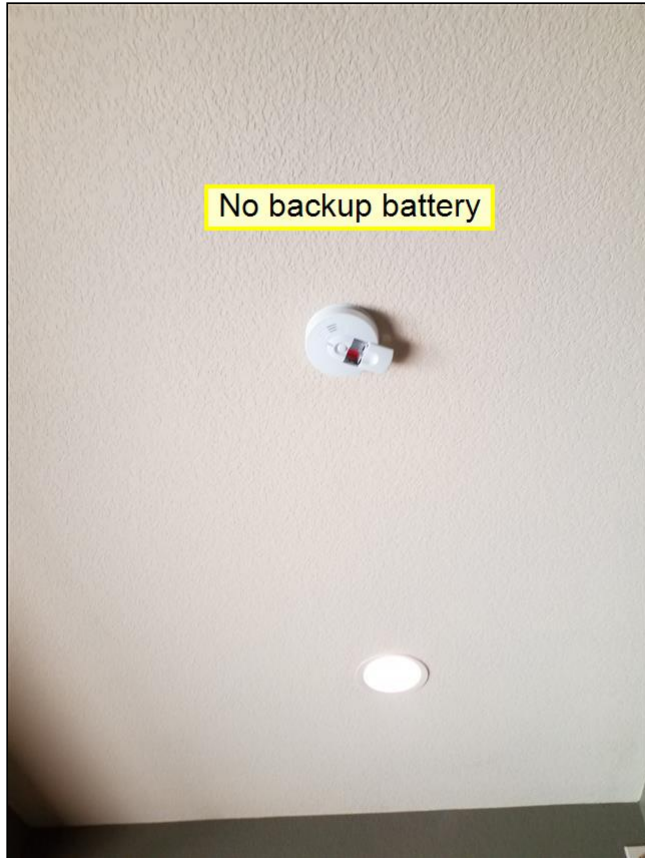
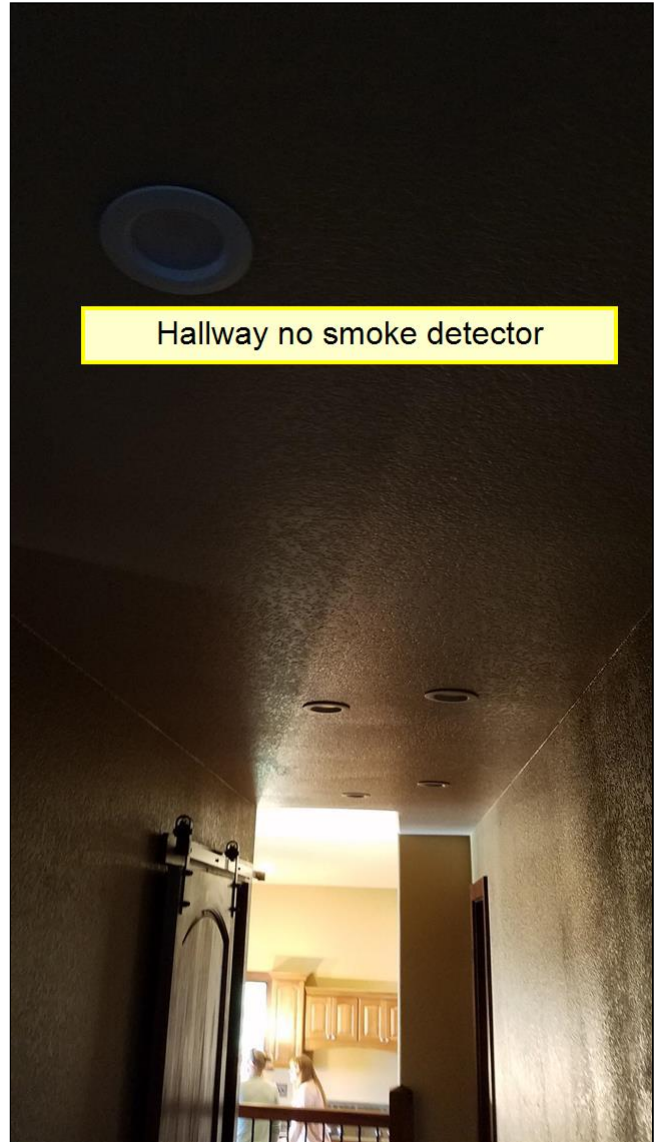
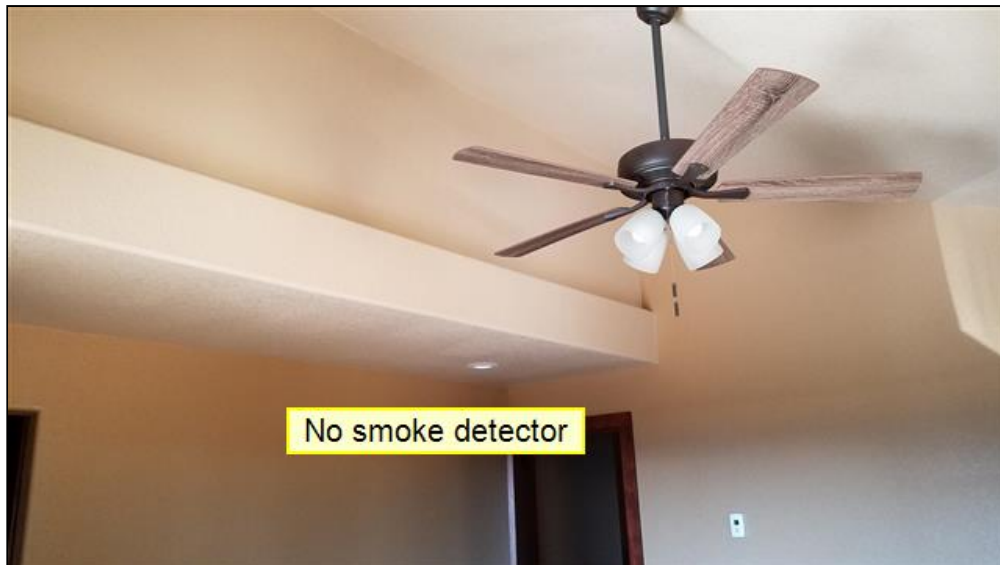
9.8 In the south guest bedroom, there was no smoke detector. Smoke detectors are required in each sleeping/bedroom. There was no smoke detector in the hallway between the bedrooms which is also required. I recommend having a smoke detector installed prior to taking ownership.

In the south guest bedroom, there was no smoke detector. Smoke detectors are required in each sleeping/bedroom. There was no smoke detector in the hallway between the bedrooms which is also required. I recommend having a smoke detector installed prior to taking ownership.

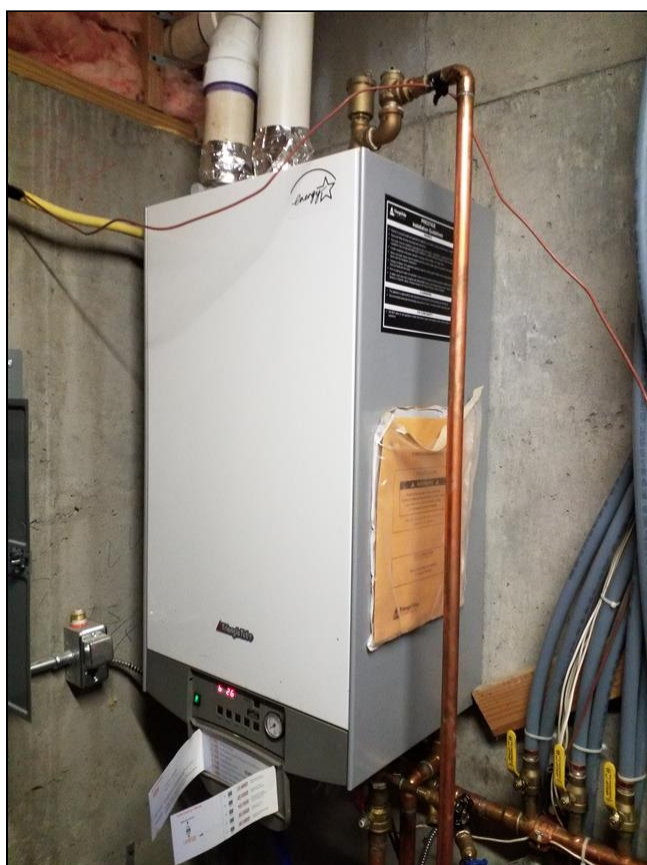
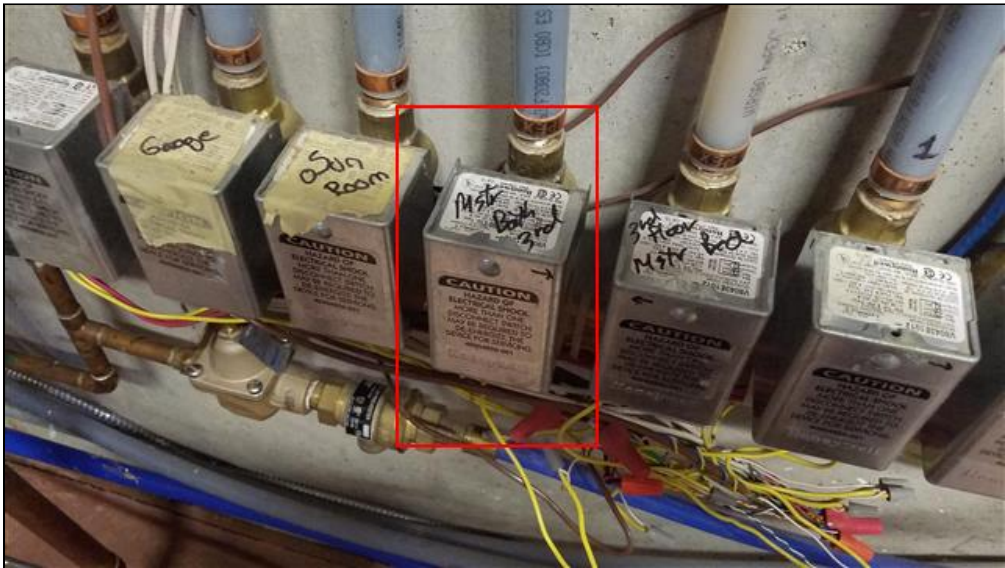
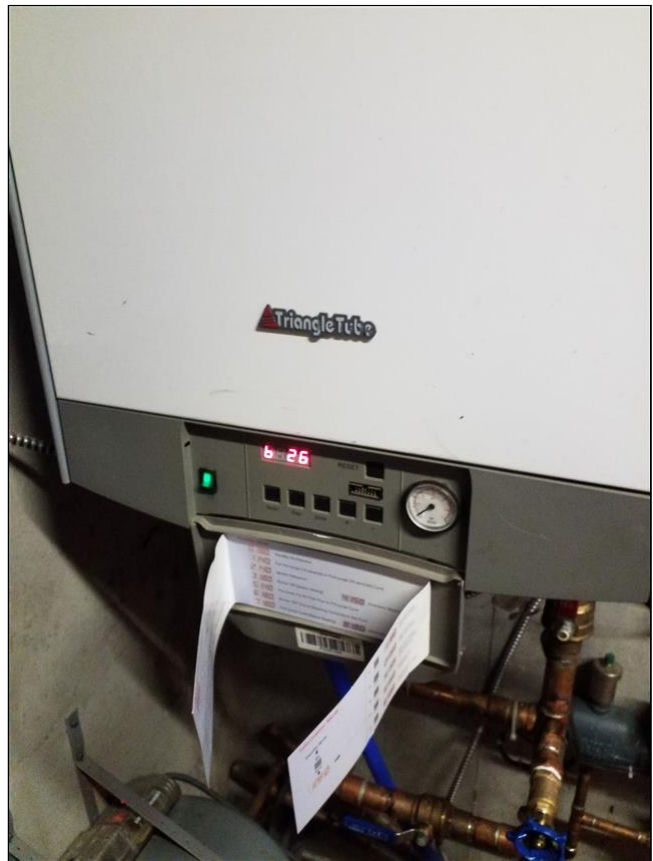
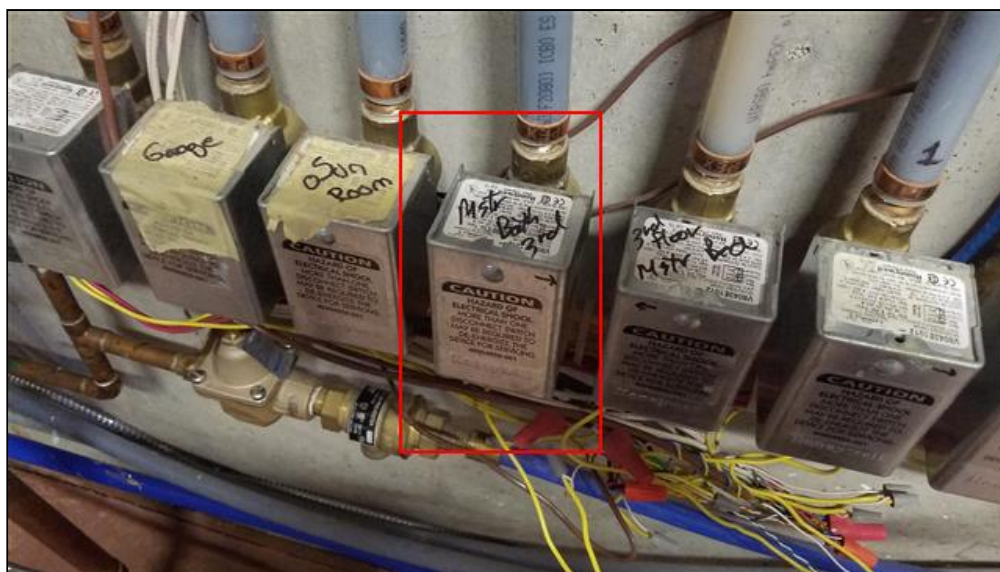
10.0 UPDATE 11/20 - The boiler is operating and supplying heat to the house. All but 1 zone is working. The Master Bath Zone is not functioning. I recommend a licensed HVAC company to repair as needed.

The house is equipped with radiant floor heating provided by the boiler system. The boiler system would not operate consistently during the inspection. Because of that, I was not able to inspect the system for adequate heat in the home. Typical boiler systems have a lifespan between 30 and 40 years. I recommend a licensed HVAC company to further evaluate and repair the boiler if needed.

UPDATE 11/20 - The boiler is operating and supplying heat to the house. All but 1 zone is working. The Master Bath Zone is not functioning. I recommend a licensed HVAC company to repair as needed.

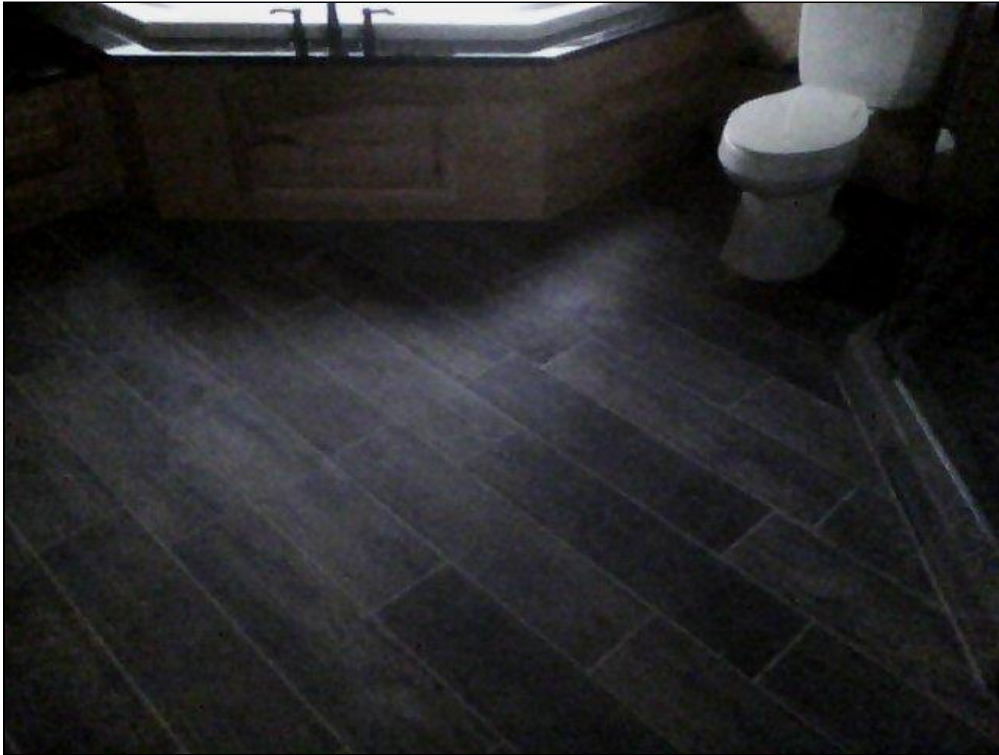
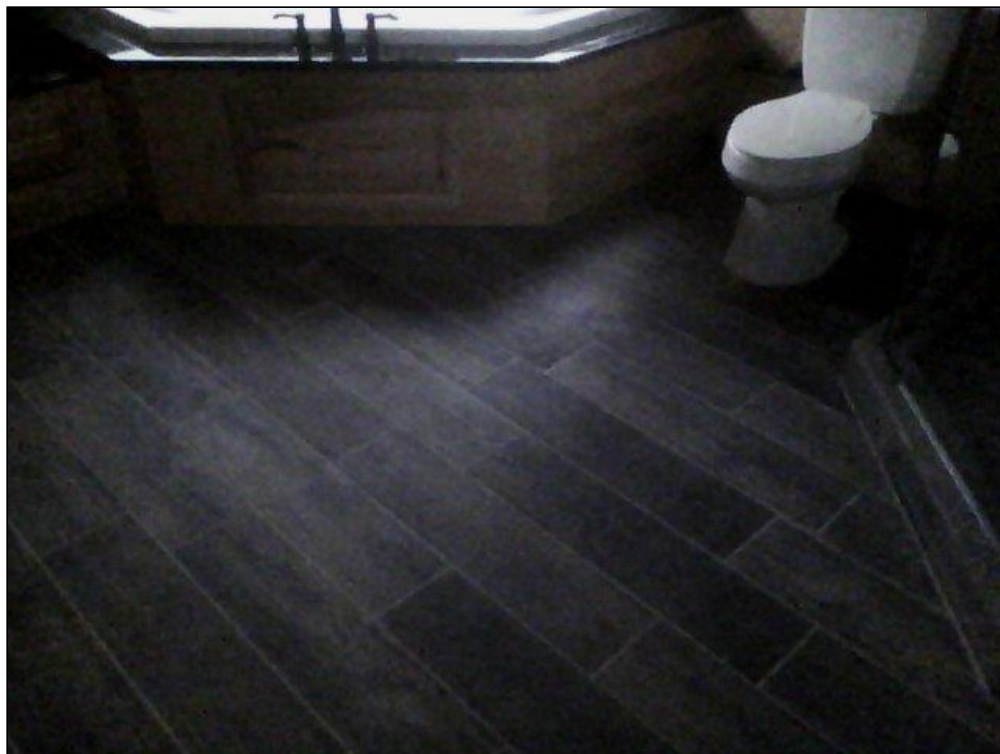
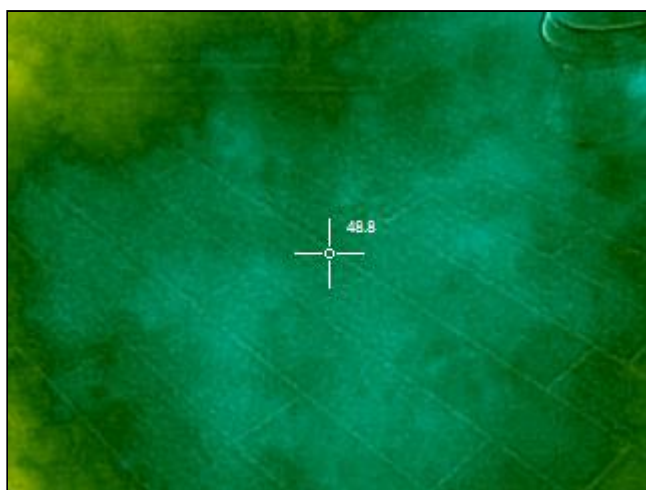
10.4 All zone functioning except Master Bath. I suspect the zone valve that controls the master bath is not functional. See 10.0 Heating Equipment for more info.

All zone functioning except Master Bath. I suspect the zone valve that controls the master bath is not functional. See 10.0 Heating Equipment for more info.
