Inspection Report

Property Address:
31468 King Valley West
Conifer CO 80433

Liberty Home Inspections, LLC

Date: 11/18/2019	Time: 09:00 AM	Report ID: 20191118-31468-King-Valley-West
Property: 31468 King Valley West Conifer CO 80433	Customer: Daniel Holton	Real Estate Professional: Lynn Westfall

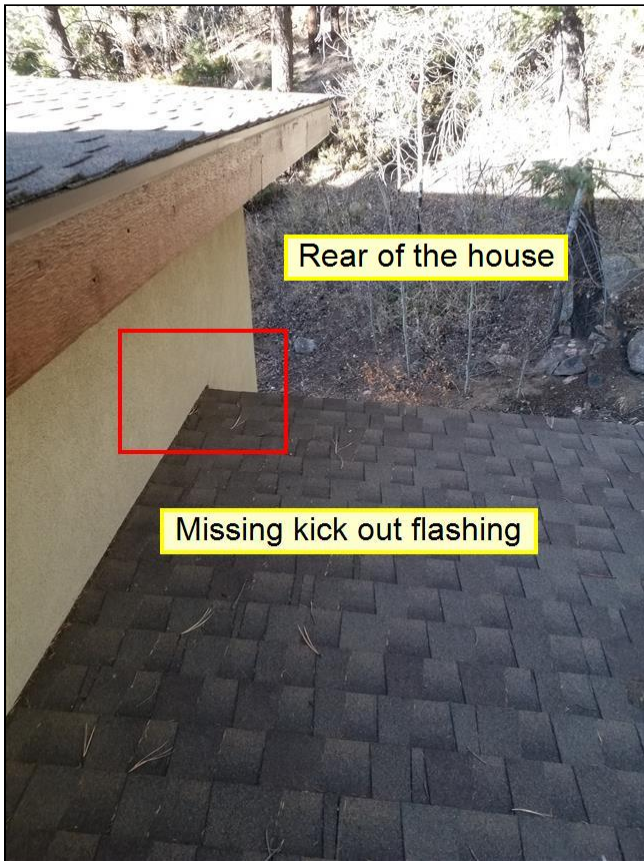
1.1 Item 3(Picture)

1.1 There are two areas that need proper kick out flashing to prevent water from deteriorating the stucco siding any further. If the flashing is not installed, the stucco siding will eventually deteriorate completely causing the stucco to fail. I recommend a licensed roofing or contractor to further evaluate and repair as needed.

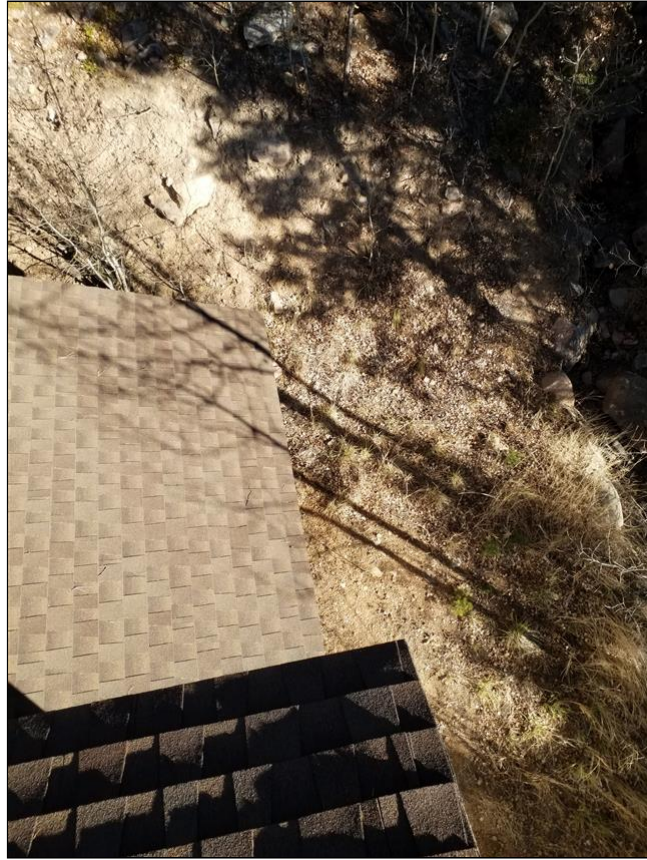
1.4 Item 2(Picture)

1.4 The house does have two gutters and downspouts that drain below grade. Additional gutters and downspouts would be beneficial in the front and rear of the home. Gutters help move water away from sensitive areas of the roof and control erosion around the foundation. I recommend having gutters installed by a qualified person or company.

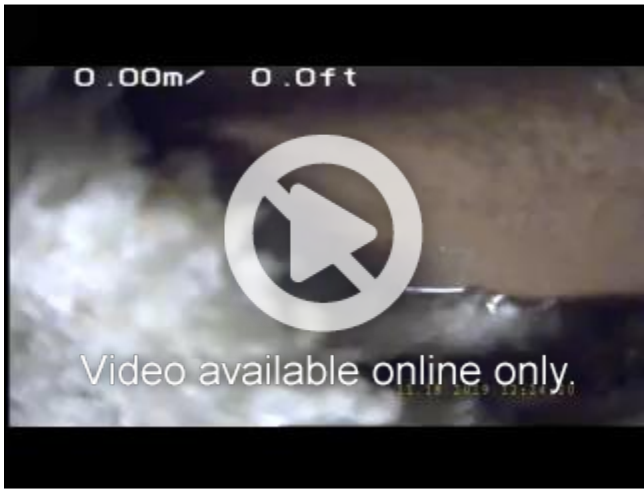
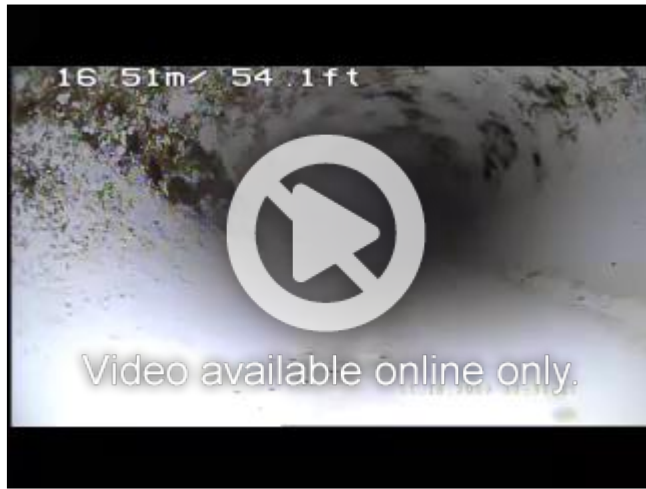
8.0 A sewer scope was performed on the property. I was unable to inspect the complete sewer line due to limitations on the camera. What was recorded indicated no issues with the sewer line. If an additional access/cleanout is located, I will perform a follow-up second sewer scope at no additional cost.

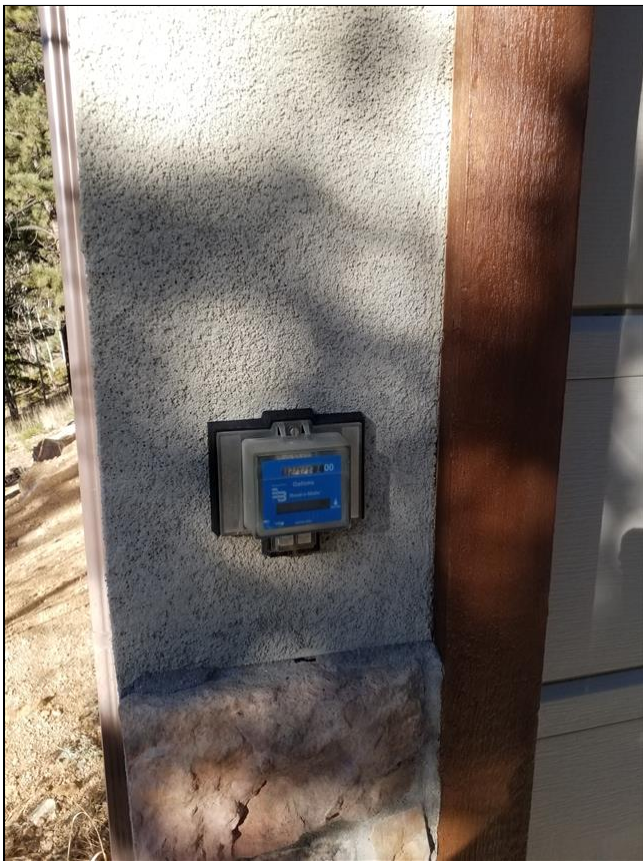
8.1 Item 1(Picture)

8.1 Water meter.

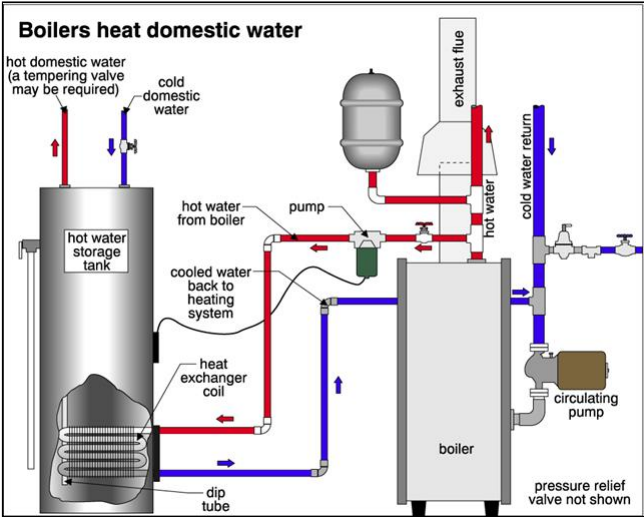
8.2 Item 2(Picture)

8.2 UPDATE 11/20 - The boiler is operating and indirect hot water tank is supplying hot water to the home.

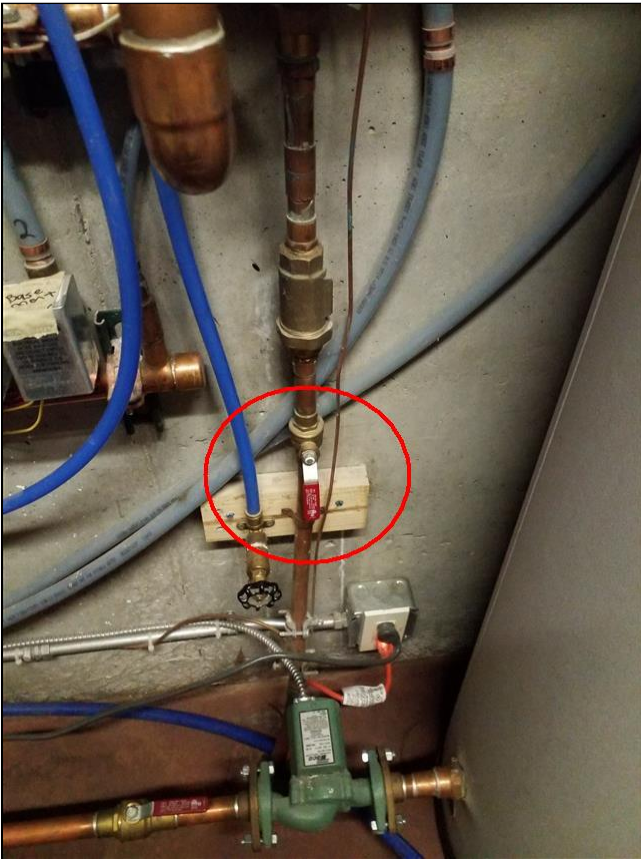
8.3 Item 1(Picture)

8.3 Main water shut off is located in the mechanical room near the hot water storage tank.

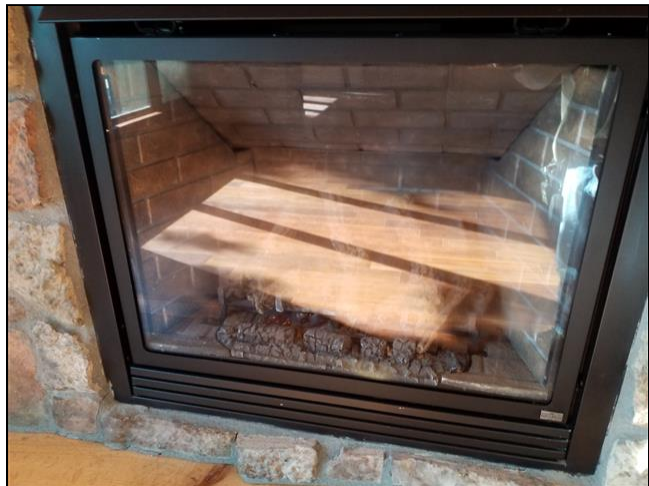
10.7 Item 1(Picture)

10.7 The house is equipped with two gas fireplaces. Both operated with no issues at the time of the inspection. Both units are UL approved.

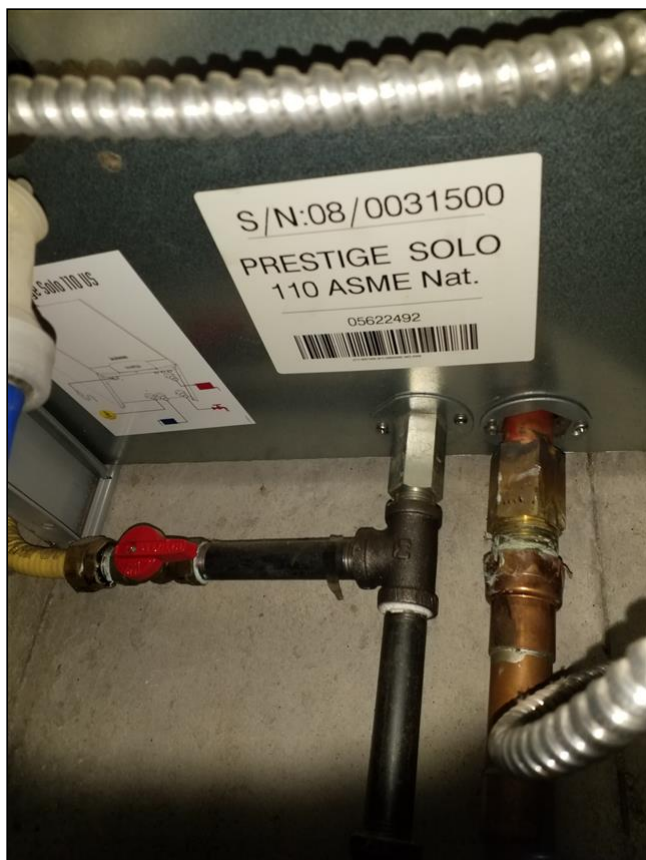
10.0 Item 3(Picture)

UPDATE 11/20 - The boiler is operating and supplying heat to the house. All but 1 zone is working. The Master Bath Zone is not functioning. I recommend a licensed HVAC company to repair as needed.

The house is equipped with radiant floor heating provided by the boiler system. The boiler system would not operate consistently during the inspection. Because of that, I was not able to inspect the system for adequate heat in the home. Typical boiler systems have a lifespan between 30 and 40 years. I recommend a licensed HVAC company to further evaluate and repair the boiler if needed.
